# Inspection Report

**Property Address:**  
1234 Main Street NE  
Washington D.C. 20019

## **Barnes Inspection Services**

## EXECUTIVE SUMMARY

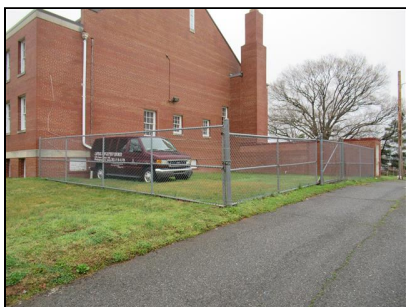
- D.** (1) On-site parking for about five vehicles on grassy fenced-in area exists to the rear of the building. The adjacent public streets offers at least 30 additional spaces.

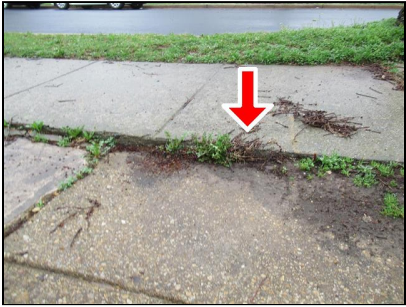
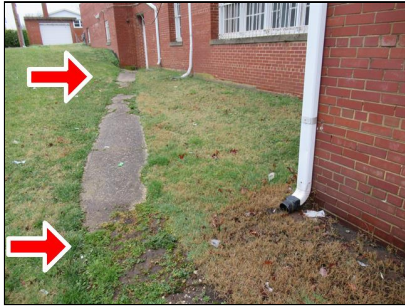
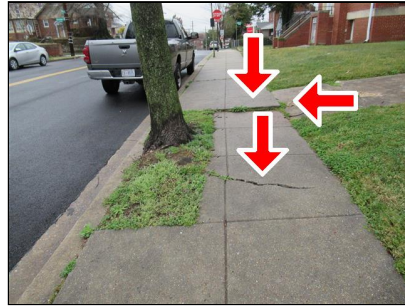
- D.** (2) The three public roadways that bound the site consist of asphalt pavement and granite curbs. BIS understands the public street pavement and curbs are maintained by Washington, DC transportation department.
- E.** (1) Pedestrian paving consisted of concrete sidewalk. Small sections of concrete walks and/or landings led to the building egresses. The concrete surfaces appeared to be in overall fair condition with several poor/critical areas that represented

trip hazards and need to be repaired/replaced for safety purposes along the left sidewalk leading to a side egress (Photos 1&2) and along the right sidewalk (Photo 3).

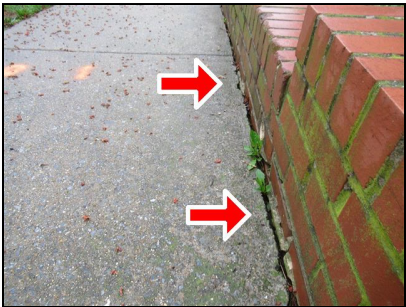
E. (2) Observed an open joint along the north wall and concrete sidewalk surface. Recommend a qualified person or contractor seal as needed and on a regular basis by routine maintenance.

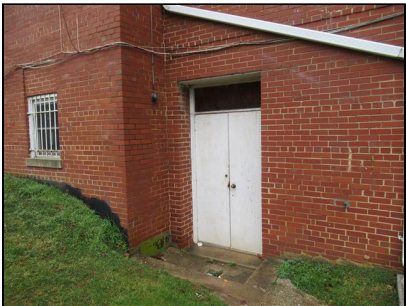
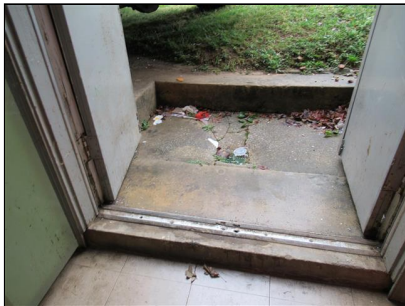
E. (3) Recommend client evaluate the need for a handicap accessibility route along the east elevation. If desired, the handicap route would require a new concrete walkway from Main Street to the east egress door. Note the elevation difference at this location will probably require a six foot or so long handicap ramp.

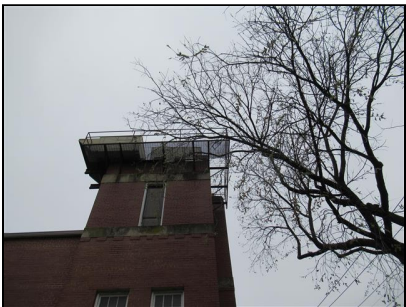
F. (1) Several mature trees exist along the public roadways. One tree was overgrown at the northeast corner and needs to be trimmed on a regular basis by a qualified contractor under routine maintenance.

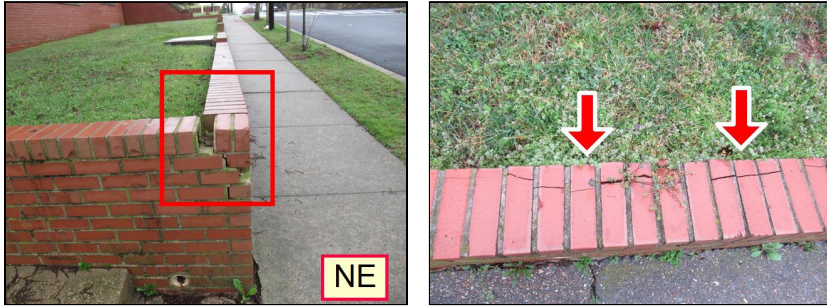
F. (3) A brick retaining wall runs along the north walkway. Observed a damaged wall section at the northeast stair location that appeared to have been caused by vehicle impact (Photo 1). Several cracking locations along its length may have been

caused by lawn mowing equipment (Photo 2). Non-damaged wall locations appear to be stable at present. Recommend a licensed contractor repair the damaged wall sections within the next year.

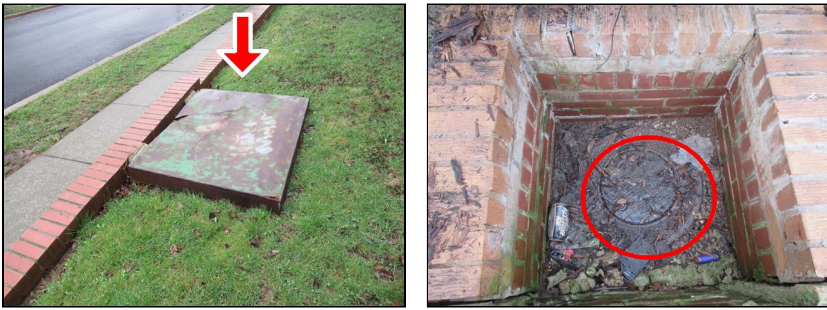
A. The water source is District of Columbia Water and Sanitary Authority (DC WASA). Fire hydrants are located along the adjacent public roadways. The cover over the water meter was deteriorated and potentially not strong enough to support a person. Recommend the cover be replaced by routine maintenance.

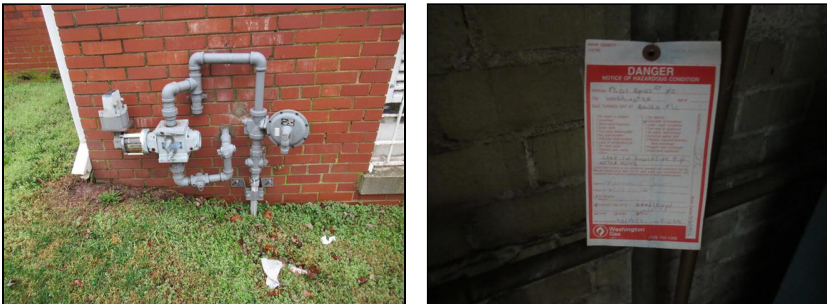
C. The fuel source is natural gas supplied by Washington Gas. Gas meter is located at the southeast corner of the building. Observed a Washington Gas danger/do not operate tag at the mechanical room gas service pipe to the boiler.

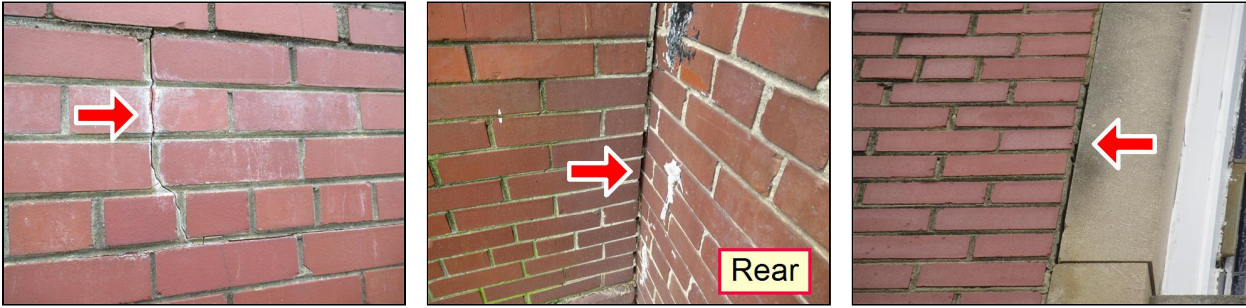
C. (1) The building's exterior walls (front and rear facades) consisted of brick masonry. Minor displacement in the form of hairline cracking was observed underneath several windows and at rear corners. Hidden damages may exist. Recommend a qualified person seal all exterior openings on a regular basis to prevent water intrusion.

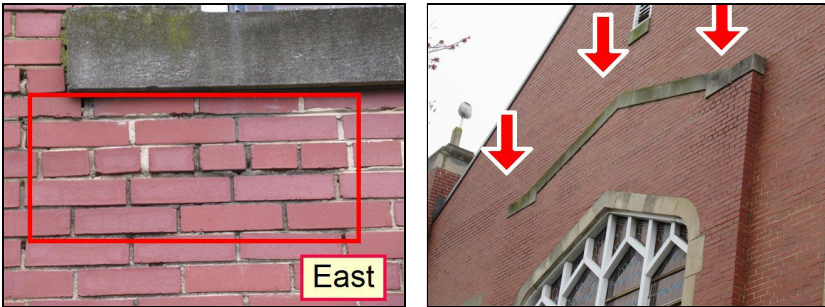
C. (2) Observed several locations of deteriorated grout material in between bricks, especially under window corners and along the front exterior wall. BIS could not access and observe the upper concrete ledge along the north wall (Photo 2) however this location is suspected to have standing storm water working its way into the building through deteriorated sealant. Deteriorated sealant and grout have caused openings in the exterior wall and have allow water intrusion as was observed during the inspection. Hidden damages may exist. Recommend a licensed masonry contractor re-point exterior wall locations and seal all openings as necessary.

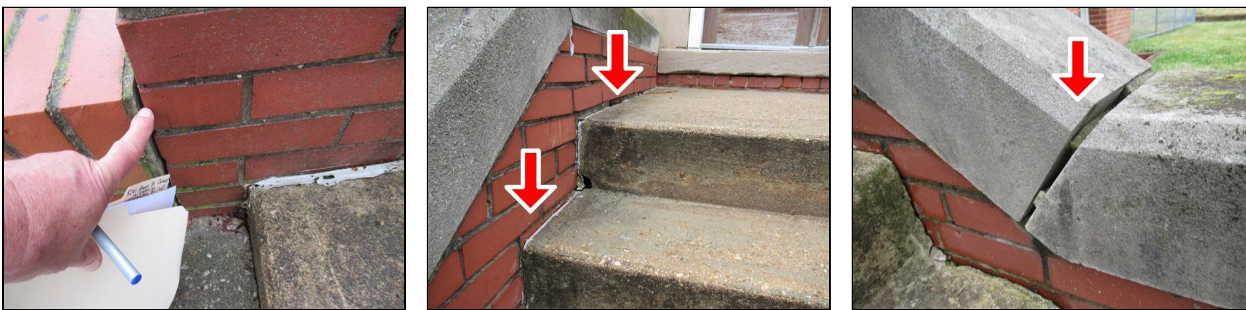
D. Observed that the three entry stair structures were slightly pulling away from the building's exterior walls (Photo 1). The concrete stairs and brick wall joint sealant was deteriorated and missing at most locations (Photo 2). Also observed open joints on the top wall concrete coping (Photo 3). Recommend a qualified contractor or person seal all openings and joints on a regular basis as part of routine maintenance.

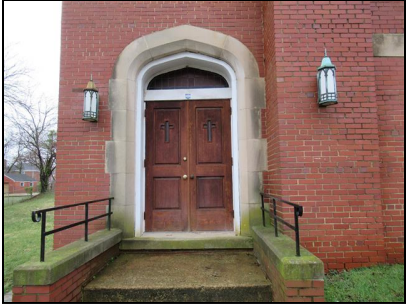
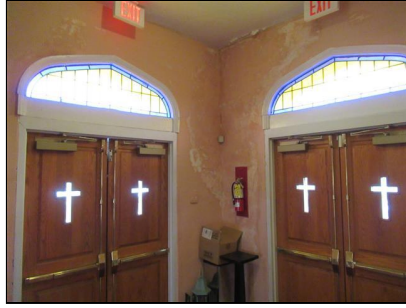
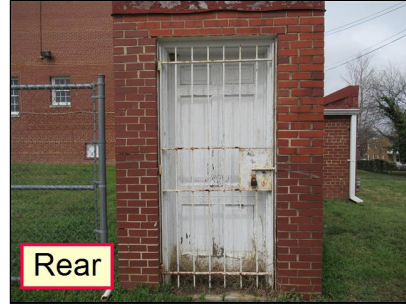
E. (1) The predominant street-side entry doors consisted of oversized solid wood normally associated with religious facilities. Other entry doors were wood in wood frames. Door hardware typically consisted of handles, panic bars and standard keysets. Doors typically swung outside and were three to four feet wide. Doors appeared to be in fair condition except for the rear egress door (Photo 3) that needs to be replaced.

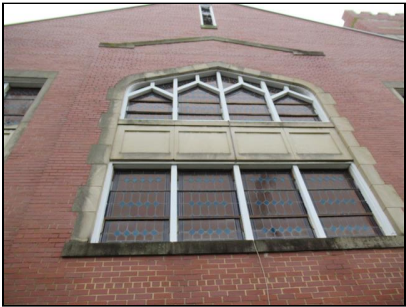
E. (2) The most predominant types of window is large stained glass decorative windows at the sanctuary. Windows have stained glass soldered in wood frames. Multiple water intrusion locations were observed along the stained glass upper joints. Recommend a window specialist seal along the window/wall joint and throughout the stained glass wood frame sections, which could prove to be very detailed. See interior section 7.A for more information on interior recommendations.

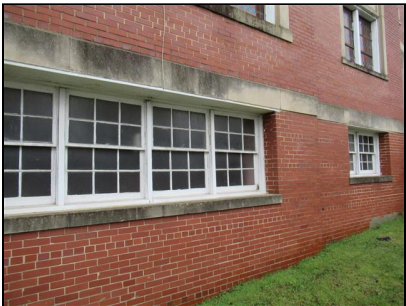
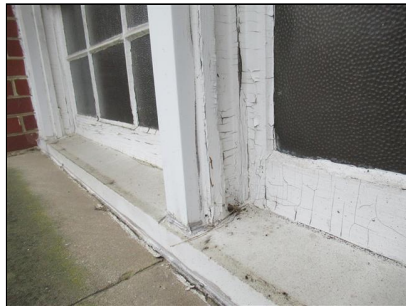
E. (3) The other type of windows include standard single hung windows in the offices and around the lower level exterior walls. Secondary windows have single pane glazing in wood frames with lower windows covered with protective steel. Observed a recently replaced lower level window in the kitchen. All other windows are aged, with peeling paint and rotted wood locations. Recommend the aged windows be replaced within three years.

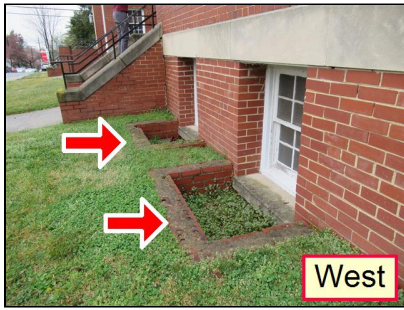
E. (4) Observed two lower level window wells that were basically full of debris and vegetation blocking what should be base drains. Recommend a qualified person clear the window well and drain and install a plastic dome to protect against further deterioration and possible water and pest infiltration by routine maintenance.

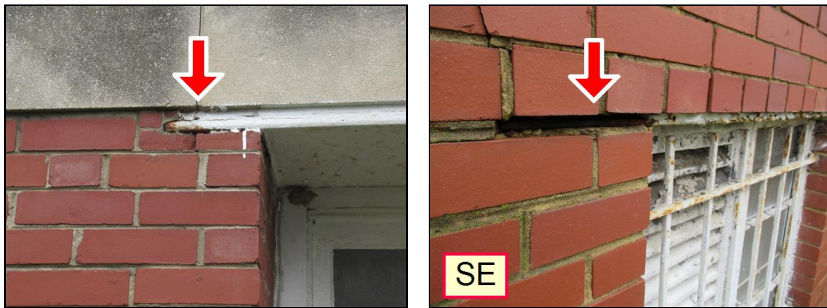
E. (5) Observed several steel window lintels rusting on its surface (see Photos). Recommend a structural specialist prep, scrape and paint lintels as needed before the steel member strength is compromised.

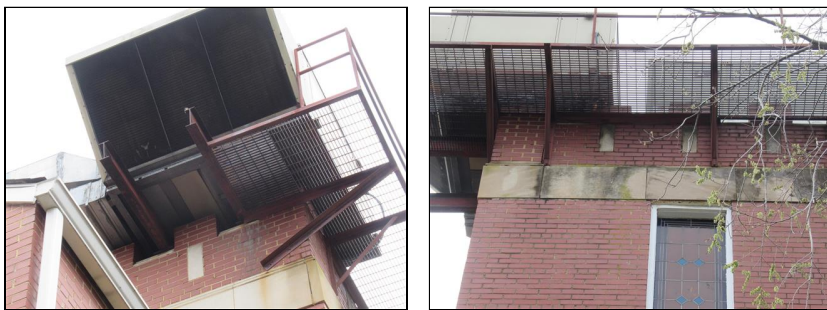
F. A metal platform extends over the northeast corner of the building to support the two rooftop air-conditioning units. Platform and steel supports appeared to be in fair condition as observed from the ground with binoculars. Client should perform a regular maintenance of scrape, prep and paint surfaces with a rust inhibitor material.

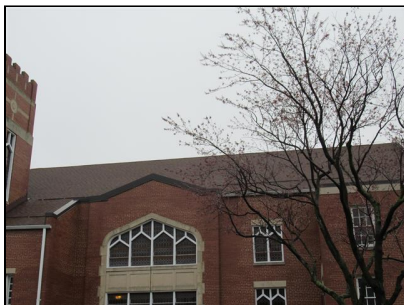
G. (1) The church building had a gable roof section over most of its footprint. The pitched roof section was covered with architectural-type shingles that were reportedly installed around 2012. Shingle roof sections were observed from the ground with binoculars and appeared to be good condition. Client should inquire about transferring shingle warranty over to themselves.

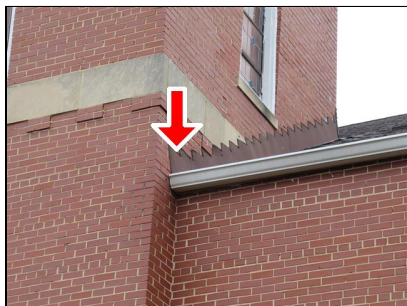
**G. (3)** Outside the pitched roof section and exterior wall adjacent to the northwest stairway lacked a kick-out flashing. Storm water may be working into the wall without such a flashing detail and contributing to the observed interior water intrusion damages. Recommend a licensed roofer install kick-out flashings here, at the northeast roof corner, and elsewhere as needed.

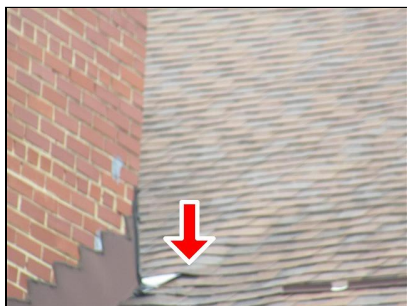
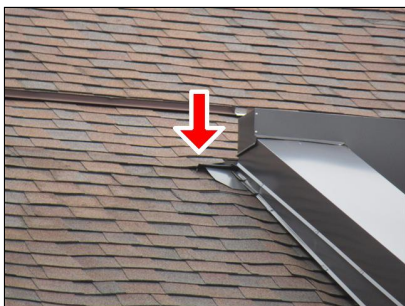
**G. (4)** Observed several openings in raised shingles that installed at corners and at flashing details. These openings provide a possible way for water intrusion. Recommend a licensed roofer further inspect on the roof surface and repair as needed.

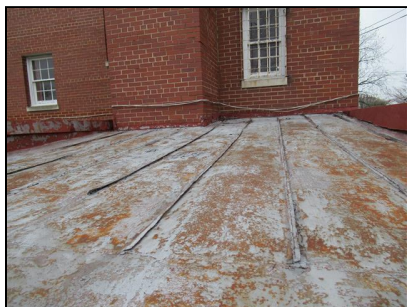
**G. (5)** Observed a lower standing seam metal roof section over the mechanical room and rear egress corridor. Roof surface appeared to be aged and in need to be coated. Recommend a licensed roofer install a surface coating to extend its useful life.

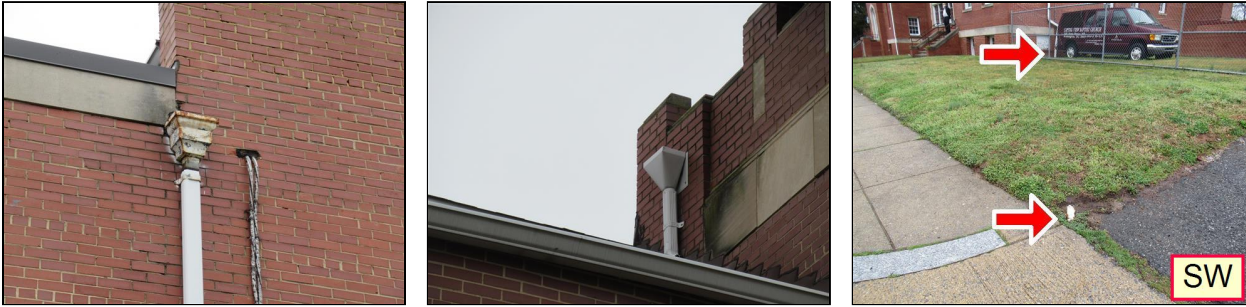
H. (1) Observed thru-wall scupper openings and scupper boxes to collect storm water and discharge to grassy locations by downspouts. The southwest downspout extended underground and discharged at an unknown location (Photo 3).

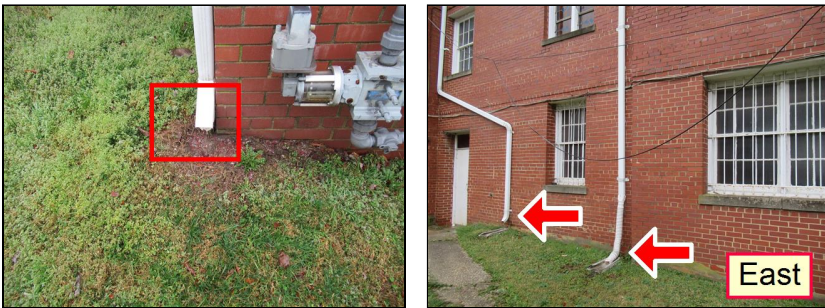
H. (2) Gutter and downspouts consisted of aluminium material. Downspouts discharged close to the building's exterior wall. BIS recommends extensions be installed at each downspout by routine maintenance so that storm water is carried at least eight feet from the wall.

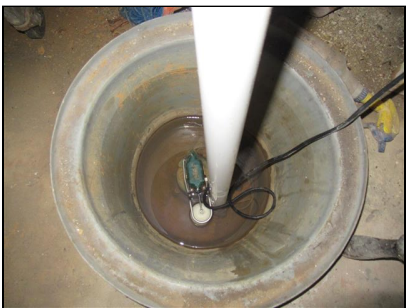
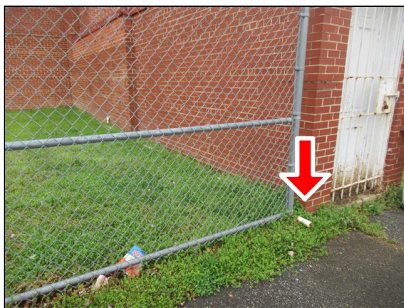
**B. (2)** Observed a sump pump pit in the basement mechanical room that discharged out the rear elevation (Photo 2). the sump pump operated when lifting the float device during the inspection. Recommend a qualified person re-install the cover as part of routine maintenance.

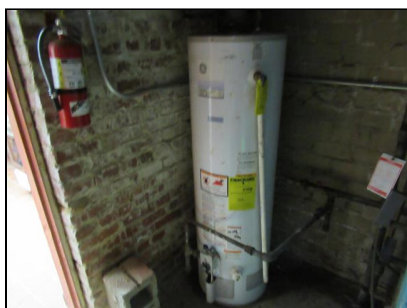
**C. (1)** Observed a gas-fired domestic water heater in the lower level mechanical equipment room. The water heater was manufactured by GE and has a 40-gallon capacity. The water heater did not supply hot water during the inspection. Recommend the water heater be replaced before moving in.

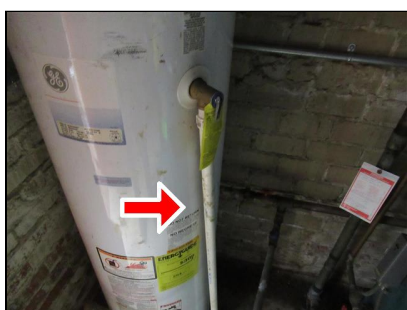
**C. (2)** The water heater contains a PVC relief pipe from its PTR valve. PVC material cannot withstand the hot temperature of escaping steam and is not allowed in this application. Recommend a qualified plumber replace the white PVC pipe section with tan CPVC material.

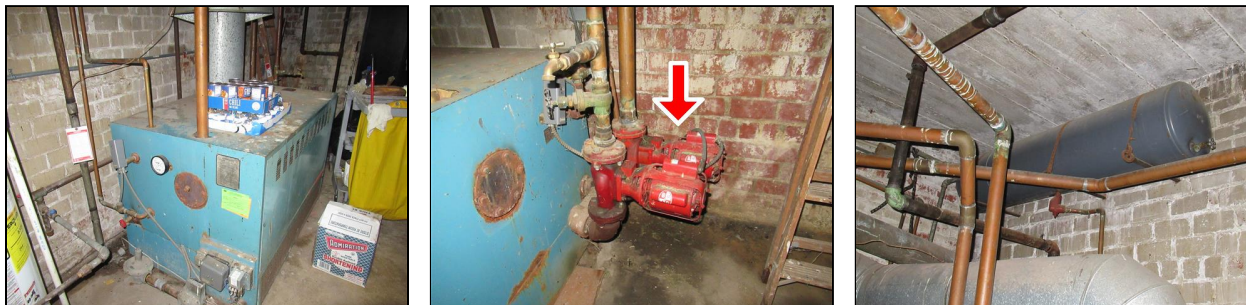
D. (1) Observed a hot-water, low-pressure, gas-fired boiler model #K-5010, serial #7643033 manufactured by Burnham. The boiler was not operated during the inspection since Washington Gas tagged the incoming gas line with a danger/do not operate label because of an active gas leak. Deacon Jones indicated that the boiler was original and has a broken part that is no longer available for repair. According to on-line information the 7-digit serial number represents that the boiler was manufactured between 1969 to 1974. The boiler had two zone circulation valves (Photo 2) and an expansion tank (Photo 3). The last approved service sticker was dated April 19, 2013. Because of the boiler age and condition, recommend the boiler be replaced before moving in. The circulation pumps and piping appeared to be in fair condition.

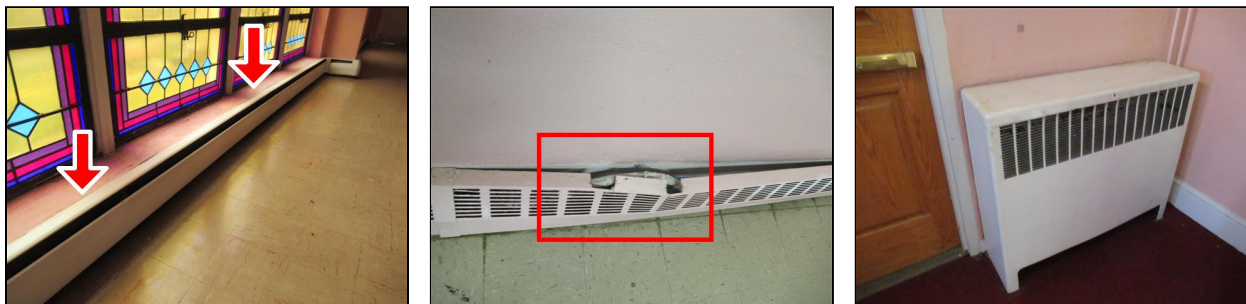
D. (2) Two heating water circulation zone pumps circulate the low-pressure, hot water throughout the building by a 2-pipe distribution system feeding baseboards and individual fan-coil units. The fan-coil units were located in the stairways, restrooms and isolated spaces. The heating hot water circulation was controlled by aged wall-mounted thermostats. Observed several locations where the baseboard has pulled away from the wall (Photo 2). Recommend a licensed HVAC further inspection and repair as needed especially after the boiler replacement is operated.

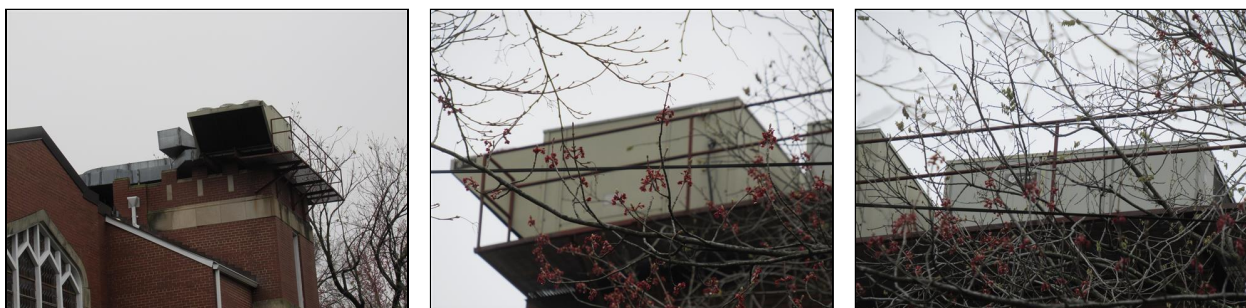
E. (1) Observed two packaged rooftop units (RTU) heating and cooling equipment and ductwork on the northeast roof corner from the ground with binoculars since the roof location could not be accessed during the inspection. The air-conditioning RTUs were manufactured by Trane and according to Deacon Jones were installed around 1999. RTUs are suspected to be about 7.5-ton and 15-ton capacity and both use R-22 refrigerate. Both RTUs appear to be in fair to poor condition and both have not been operated in over a year. Recommend both RTUs be serviced by a licensed HVAC specialist and then funded for replacement within three years.

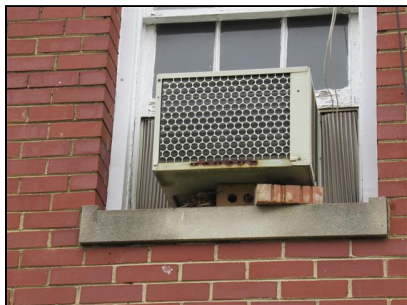
E. (2) Observed two window air-conditioning units in the southeast pastor's and trustee's offices. A/C units were aged and both need to be replaced by a qualified person under the routine maintenance program.

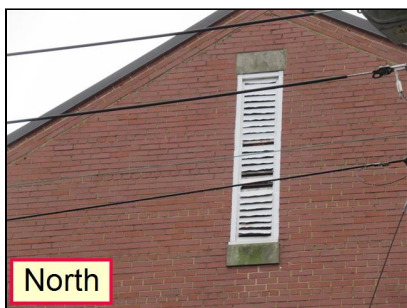
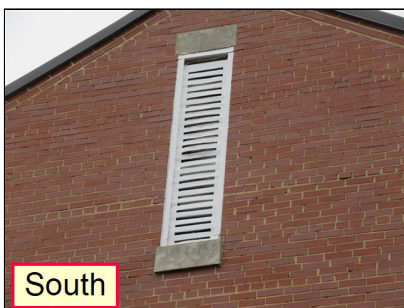
E. (3) Observed two wood gable vents for the attic - on north and south facades. Vents were covered with aged wood with openings that allow for bird intrusion. Also water intrusion is suspected. Hidden damages may exist from water, bird and pest intrusion. Recommend both gable vents be replaced with weather and pest resistant construction.

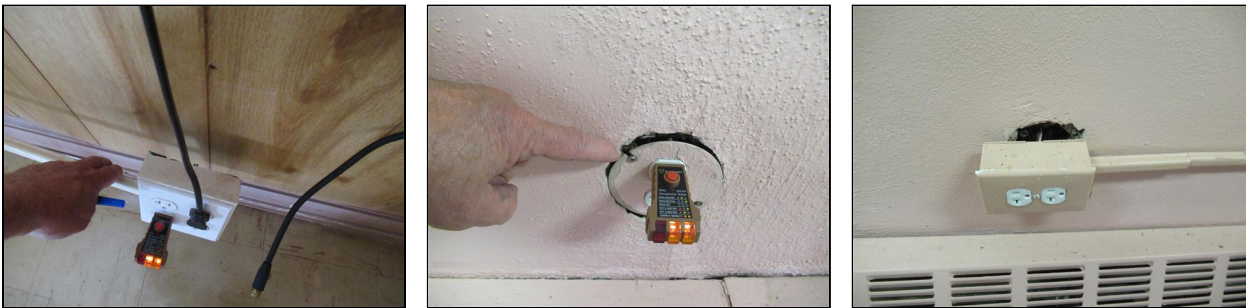
G. (3) At least six "three-prong" outlets are loose in wall including four in event space, sanctuary right of stage, and trustee office. These loose outlets may cause the wiring to flex back and forth and potentially cause an arc or failure. Electrical issues are considered a hazard until repaired. Recommend a qualified licensed electrician should inspect all outlets and correct as needed.

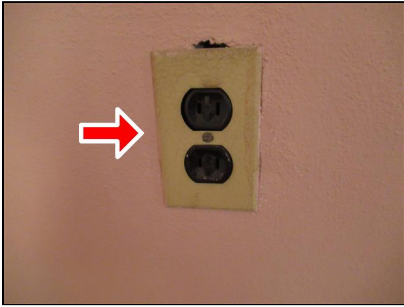
G. (5) One "two-prong" outlet is not grounded in the sanctuary left of raised pulpit. Electrical issues are considered a hazard until repaired. A qualified licensed electrician should perform repairs that involve wiring.

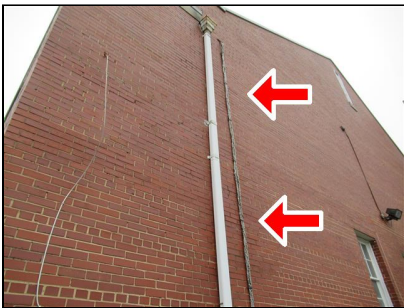
G. (6) Observed that the exterior conductor sheathing from the lower level electrical room to the upper offices is severely deteriorated. This is a potential safety issue. Recommend a licensed contractor replace the exterior electrical conductors before moving in.

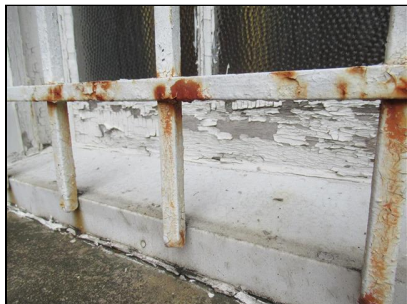
**E.** Observed security rusting steel bars over the lower level windows that be scrapped and painted. However BIS did not observe building entry security devices or cameras. Recommend a security expert be contracted in the near future to upgrade the building and site security.

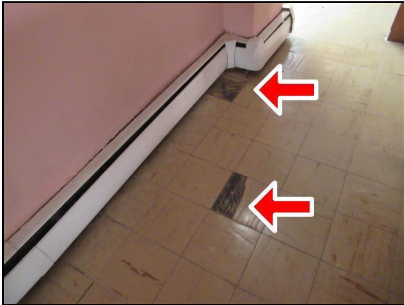
A. (2) The sanctuary and balcony floors contained a 9" x 9" tile. Because of its age and color, the tile and mastic is believed to contain asbestos material and as such should be treated as a hazardous material. The tile would be satisfactory as is except for several tiles along the side baseboard that exhibit deterioration. Once deteriorated the tile becomes friable and emit air-borne substances. While this tile has not been tested for the presence or asbestos or for a friable state, BIS advises client on two courses of future action: 1) abate/remove or 2) encapsulate or cover. The existing condition poses a liability to the church and should be address in the near future. Recommend the church have the tile and mastic material tested for the presence of asbestos material.

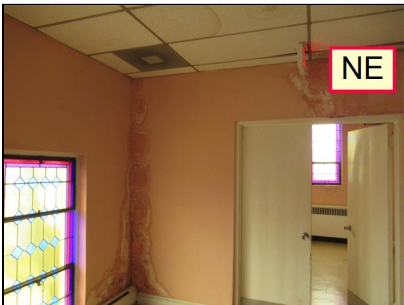
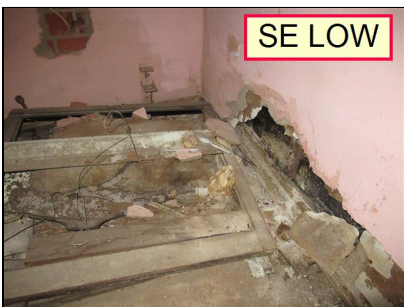
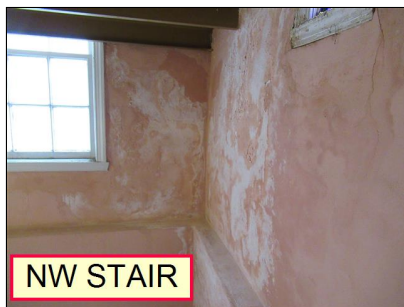
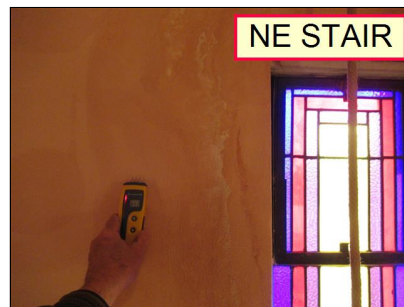
A. (3) BIS observed multiple locations water intrusion throughout the building at three stairways (northeast, northwest and southeast) and along the sanctuary north wall. There may be other locations that were inaccessible or covered by furnishings. Hidden damages may exist. A moisture meter showed signs of elevated moisture (last rain was the previous day) at three active leak locations: 1) above center stained glass window, 2) northeast corner on both side of staircase wall and 3) northwest stair near bell pull rope. Deteriorated plaster wall surfaces existed at each water intrusion location along with water stains. Several of these stains were dark in color and to BIS represented signs of microbial growth. BIS did not inspect, test or determine if this growth is or is not a health hazard. The underlying cause is moisture or dampness. Recommend you contact a mold inspector or expert for investigation and correction, which probably includes removing damages areas, replace the plastic wall materials and exterior sealant/re-pointing as described in Section 4.

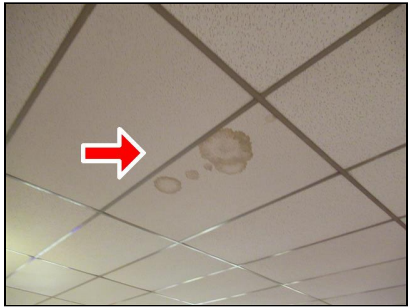
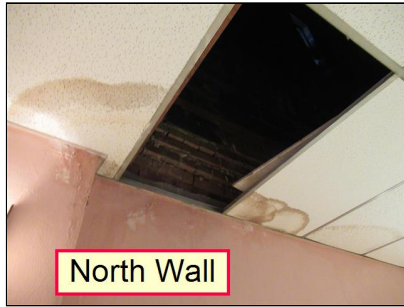
A. (4) BIS observed ceiling stains throughout the church, especially above the sanctuary and balcony area. Suspect water intrusion from roof leaks and window/wall openings. Hidden damages may exist. See other sections for window, wall and roofing recommendations. Recommend client remove the damaged ceiling sections through routine maintenance and replace with new tiles so they can be observed for future water intrusion staining after the window, wall and roof recommendations are completed.

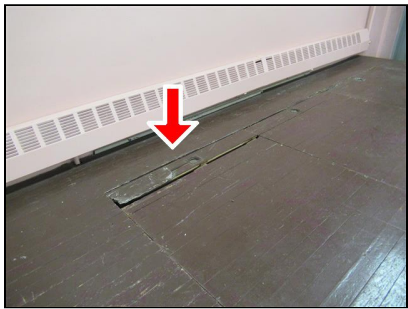
A. (5) The lower level event room stage has damaged wood boards that represent a potential fall or injury hazard. Recommend stage be repaired by routine maintenance as needed for safety purposes.

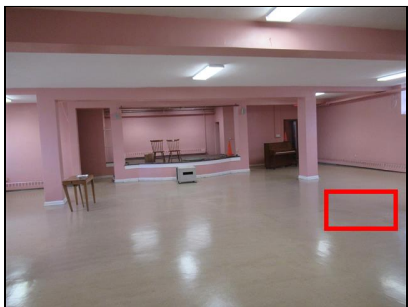
A. (6) Observed two areas of wet vinyl tile flooring at the lower level event room that were near each other in the center west area (Photo 1). Each area was about six feet by six feet. BIS did not observe stained plaster ceiling above either area - so plumbing or roof leaks were unlikely. Areas were somewhat away from the windows - so window leaks were unlikely. BIS suspects someone was mopping the floor over the last several days and left standing water.

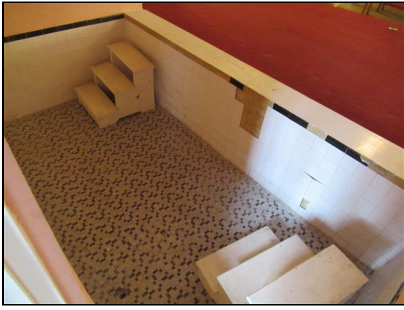
C. (3) Observed a baptism vault behind the sanctuary pulpit that contained isolated missing and damaged ceramic tiles. BIS did not observe a water heater, pump or lower level baptism vault. Recommend a qualified contractor repair/replace the tile surface as needed and replace the heater and pump.

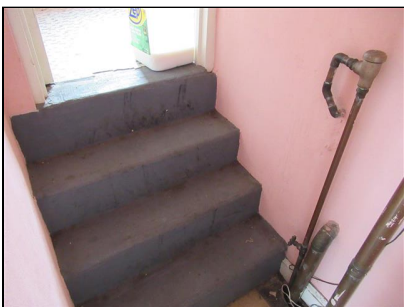
C. (6) Observed stairs leading to the sanctuary that lacked a handrail. This is a potential fall or injury issue. Recommend a qualified contractor install a handrail as needed.
