Inspection Report

111 Smith Road
Baltimore MD 21345

Barnes Inspection Services

Date: 11/12/2013	Time: 02:00 PM	Report ID: 1311.01
Property: 111 Smith Road Baltimore MD 21345	Customer: John Smith	Real Estate Professional: John Doe Colliers International

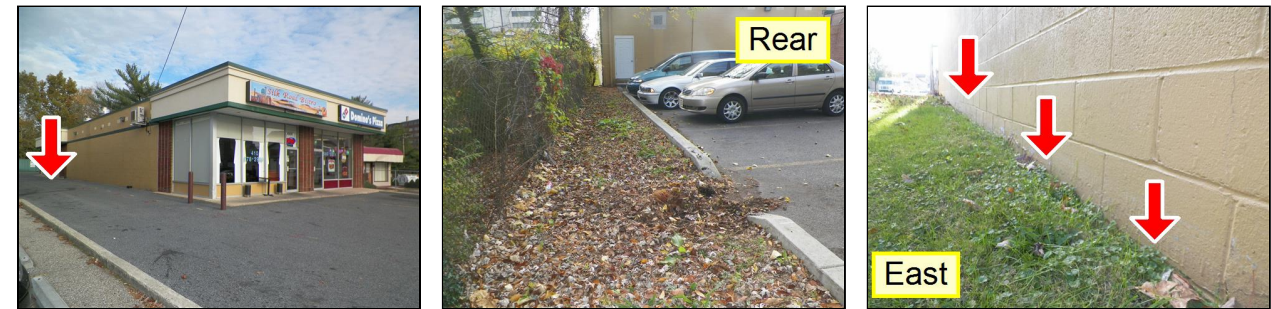
A. The property was generally flat with a high-elevation contour location as indicated on Photo 1. Pavement slopes both toward the front (Smith Road) and rear east (golf course). Parking and service drive pavement appeared to be properly sloped to discharge storm water onto Smith Road and onto two rear curb cuts. Property mainly consists of building and asphalt pavement. Observed a slight negative slope to the grassy area along the east exterior wall (see Photo 3). This area should be raised to provide positive drainage (1" per foot) away from the foundation wall.

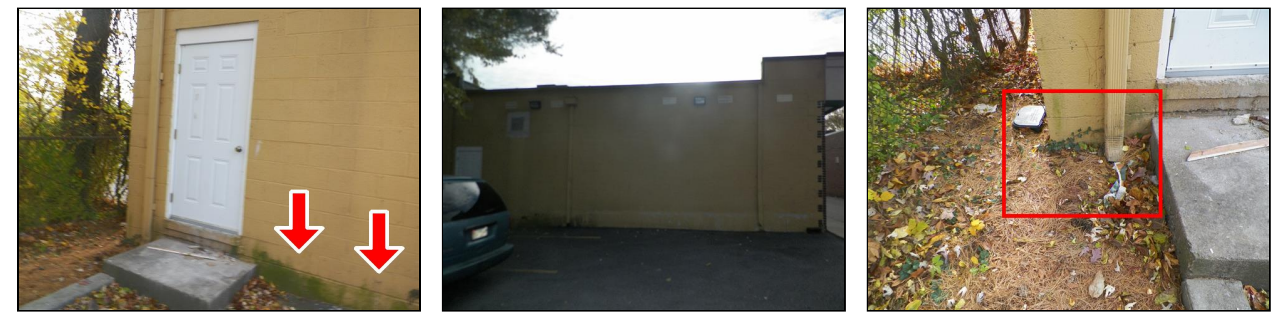
B. It appeared that the property had a peak elevation near the northwest corner of the building. All pavement to the south drained by sheet flow onto Smith Road to storm drain inlets near Main Road and eventually discharges into a Baltimore County 36" storm drain main along Main Road. Pavement to the north, basically the rear parking lot, drains in an easterly direction to two curb cuts that discharge the storm water onto grassy area of the golf course property.

Based on site observations, it appeared that approximately 98 percent of the site was covered with impervious surface material, either pavement or roof. The building was drained by a primary roof drain to scupper box and a gutter/downspout system along the north roof line. Repairs/replacement to sections of the roof drainage are recommended, as missing parts, vegetation surface staining and erosion were noted along the rear of the building.

In general the site drainage was overall satisfactory with parking and service drive pavement to be properly sloped to discharge storm water onto Smith Road and onto two rear curb cuts. Recommend installation of underground roof drainage piping to eliminate foundation wall water intrusion, pavement erosion and possible icing conditions over the cold months.

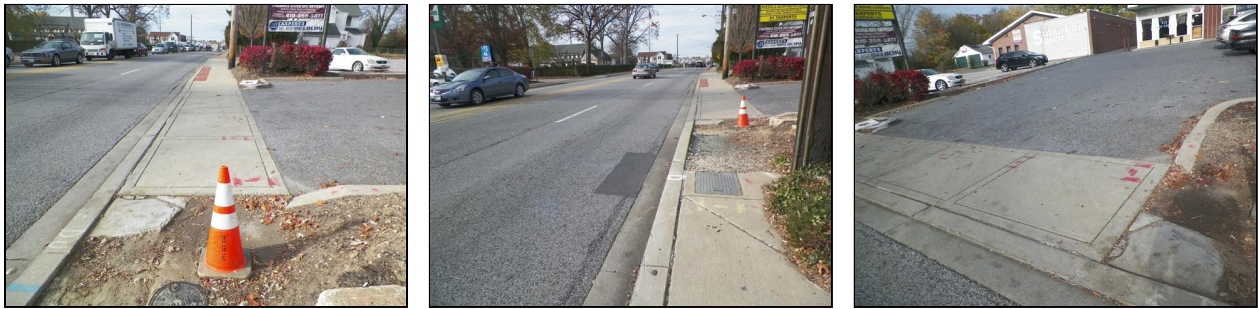
C. (1) Property was accessed by a 2-way, 30'+ wide entrance roadway from Smith Road. Entrance provided direct access to a service drive for the front and rear parking areas. The general flow of traffic appeared to be smooth, however several Bistro vehicles illegally parked along the service drive during the inspection and thus constricted traffic circulation at that location. During the mid to late afternoon hours this did not appear to be an issue as on-site traffic volume was very low.

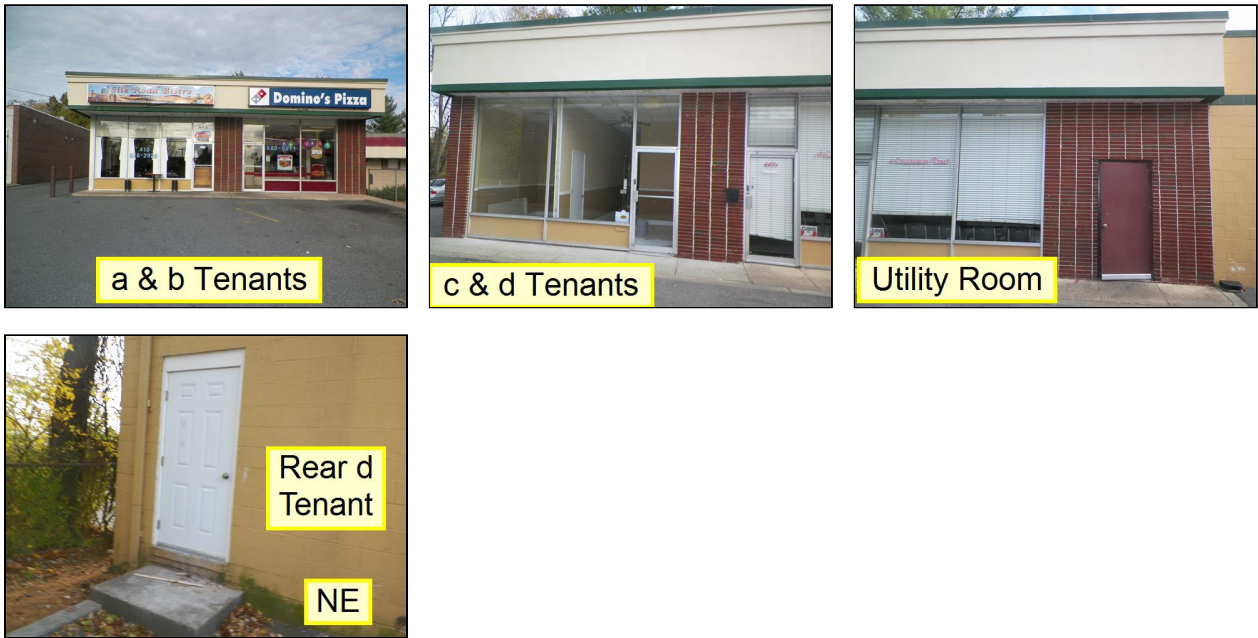
C. (2) Building had four tenants with a & b egress doors along the front/south and c & d along the west. Additional egress doors included a common utility room door along the west wall and what appeared to be a tenant d rear door at the northeast corner of the building.

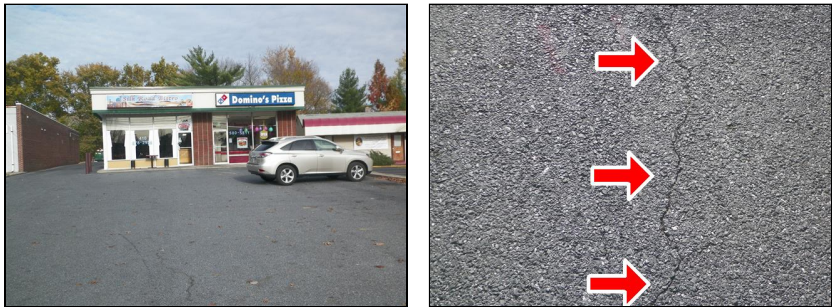
D. (1) Asphalt pavement surfaces appeared to be recent and were generally in tact. Only observed a surface crack running along the middle of the service drive (see Photo 3). Concrete curb outlined the rear parking pavement and was found to be in good condition. Recommend all cracks be sealed on a regular basis to minimize water intrusion into the pavement section.

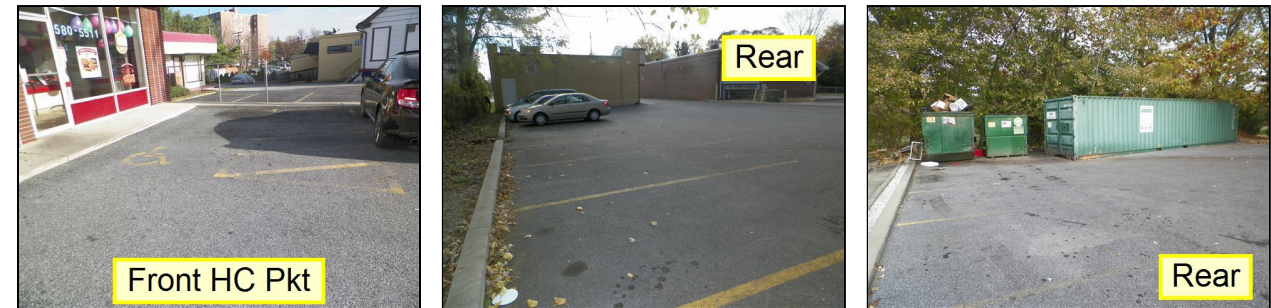
D. (2) BIS counted a total of 27 on-site parking spaces with 26 regular sized spaces along with 1 reserved handicap parking space in front with a 6' wide accessible aisle. This handicap space should contain an 8' wide access aisle for van accessibility per ADA regulations. Also the accessible route had a 1" to 2" elevation difference between the pavement and sidewalk surface leading to the tenant entry doors. The regular spaces were measured as 9' x 18.5', which exceeds Baltimore County requirements of 8.5' x 18'. Recommend one van accessible space with proper signage and accessible route be installed at front of building. Also recommend re-stripping of all parking spaces as the lines have faded.

Zoning Code also contains an special reduction for a restaurant in the Pikesville revitalization district requires 5 spaces per 1,000 square feet of space (8). Adding this revised requirement the site should contain 23 spaces, which exist. BIS could not verify if an approved parking variance exists or if the lower restaurant requirement are in place. BIS asked Zoning representative if a transfer of property Ownership and no changes in zoning or tenants would require a zoning review - he answered no. Client may want to verify that on-site parking requirements are satisfied before purchasing the property or request a parking variance.

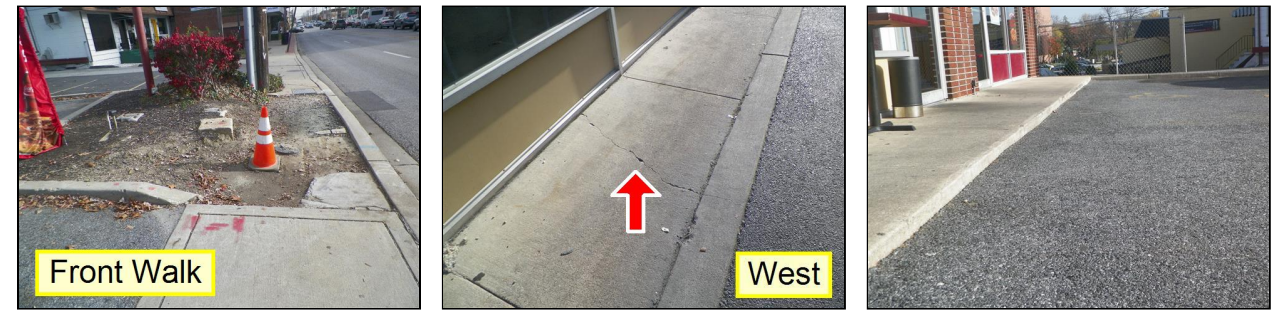
E. (1) The pedestrian paving consisted of concrete sidewalk along the front and west side of the building and along Smith Road. It appeared a private or public agency had recently completed construction along Smith Road fronting the property and had not replaced the removed sections of sidewalk. Note Miss Utility markings on Photo 1. Client should verify that others will re-install front sidewalk sections or he may have to. Several on-site sidewalk cracks need to be sealed to prevent further deterioration from water intrusion. As stated in 4.D.(2) the ADA accessible route had a 1" to 2" elevation difference between the pavement and sidewalk surface therefore requiring a small curb cut to be installed (see Photo 3).

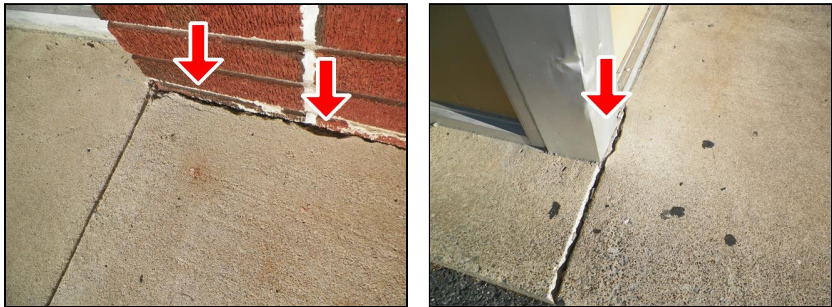
E. (2) Observed open joints along sidewalk and building. Recommend all joints and other openings be sealed on a regular basis.

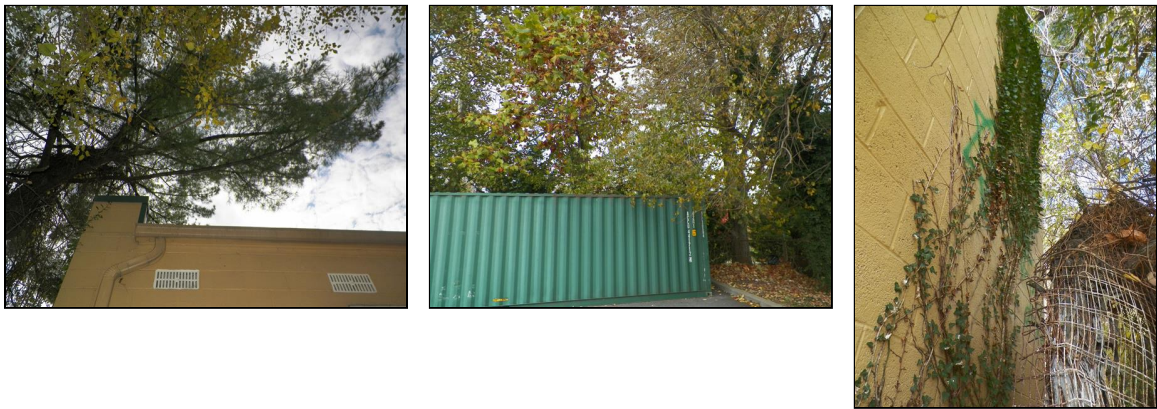
F. (1) Attractive mature trees lined the north and northeast property lines from the golf course site. However several trees and other smaller vegetation were overgrown through the north property line fence and over the northeast roof area. Vines were climbing up the northeast corner and could intrude into mortar joints. Recommend removal of all vines and trim vegetation (or request golf course to) throughout these areas.

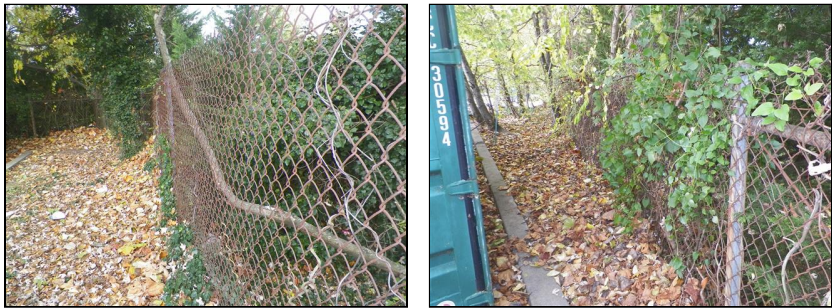
F. (2) The chain link fabric on the property fencing was rusted throughout, not to mention that vegetation was growing across the fencing. Recommend trim all vegetation and replacement of fabric in the near future.

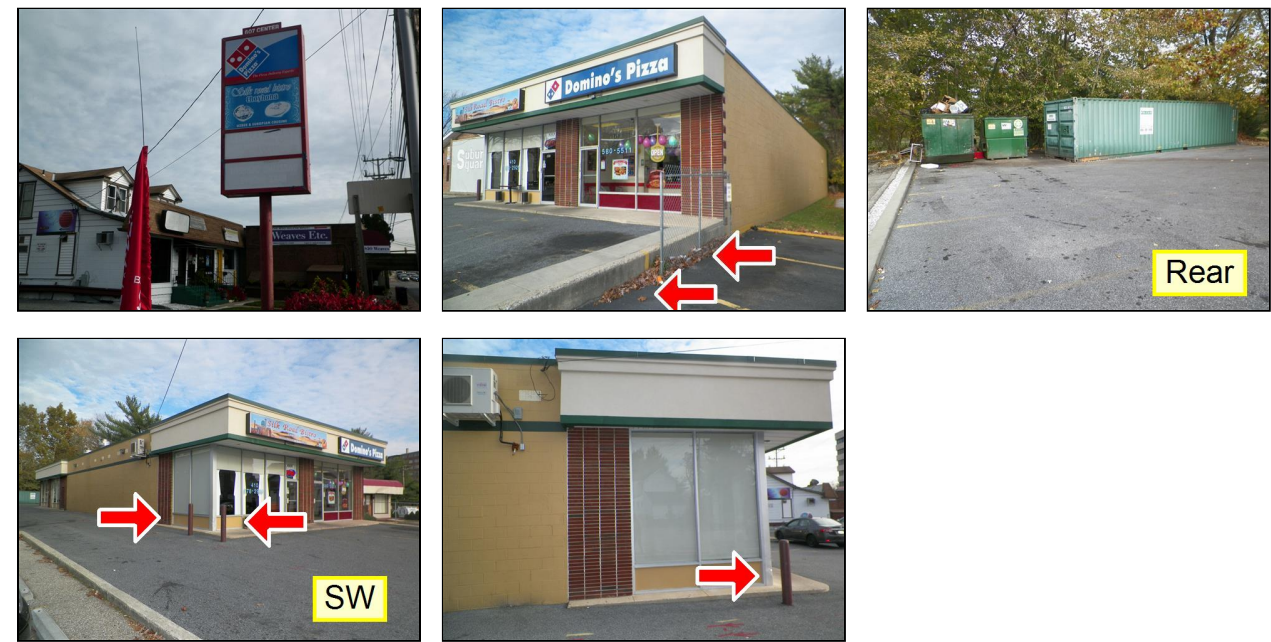
F. (3) Other site appurtenances included an attractive pylon signage at Smith Road, a "knee-high" concrete retaining wall along the front east property line, two dumpsters/storage container at rear parking area, and two pipe bollards at the southwest corner of the building. Note as discussed on 2.D the dumpsters and storage container reduced the total number of parking spaces by four. The pipe bollards at the southwest corner of the building constricted the width of the service drive down to 16 feet at their location thus only allowing 1 vehicle to safely pass at that point. Recommend both bollards be painted yellow for safety purposes.

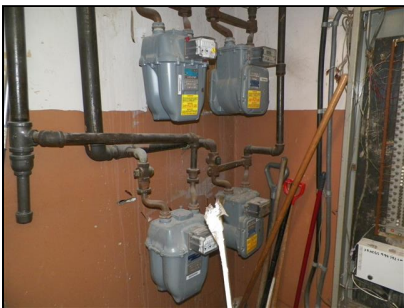
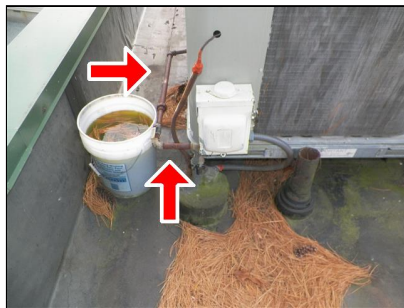
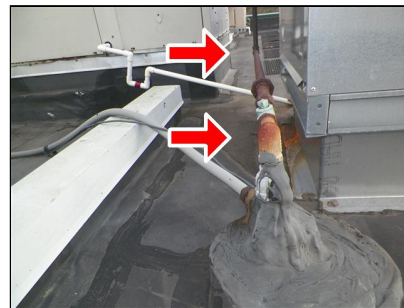
C. According to Exhibit C, Baltimore Gas & Electric (BGE) supplies an underground gas line of unknown size off a 12" low-pressure gas main along Smith Road. Underground gas pipe runs directly into the building from the gas valve location. Observed 4 gas meters in the utility room. Preventive maintenance on the roof exterior gas distribution system appears to be necessary from the observed rusted pipe sections.

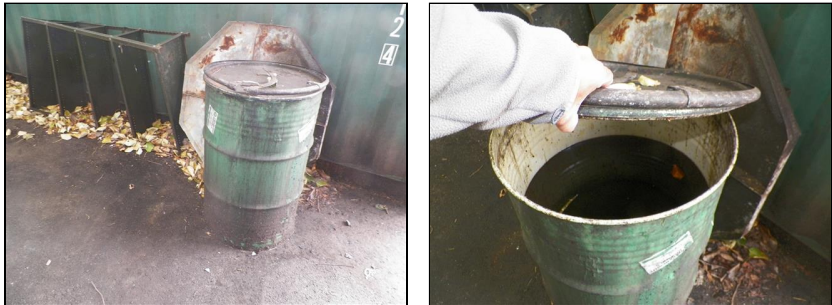
F. Observed a storage drum almost full of what appeared to be used deep fryer oil. Drum lid was unlocked. Recommend drum be stored in an approved safety/enclosed area labeled "No Smoking Flammable Materials". Oil spillage would be costly to clean-up.

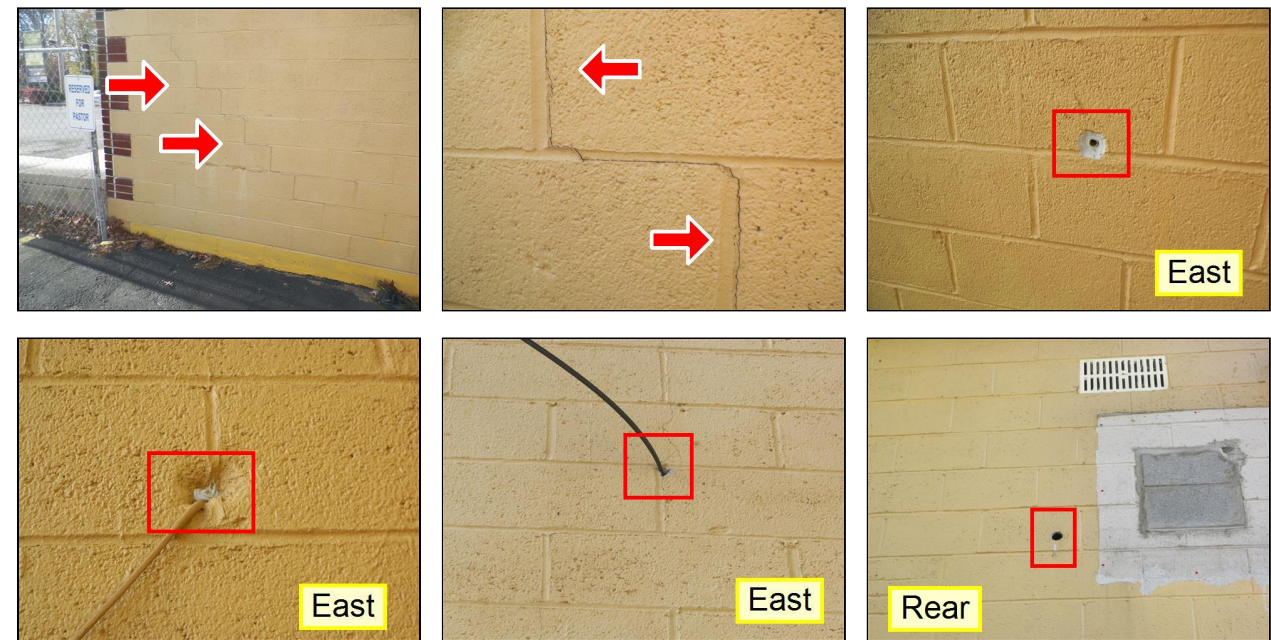
C. The building's exterior walls (facades) consisted of CMU/brick masonry. Observed a series of hairline cracking, both step and vertical, along the east wall. These hairline settlement cracks do not appear significant at this time to require repairs. However due to freeze/thaw, cracks should be sealed to minimize further chipping away, flaking or deterioration. Typical cracks should be sealed with a sealer and may need periodical sealing. Also observed several wall penetrations that may allow water to intrude, all open penetrations should be sealed on a regular basis. See 2A. for providing positive drainage away from the east wall.

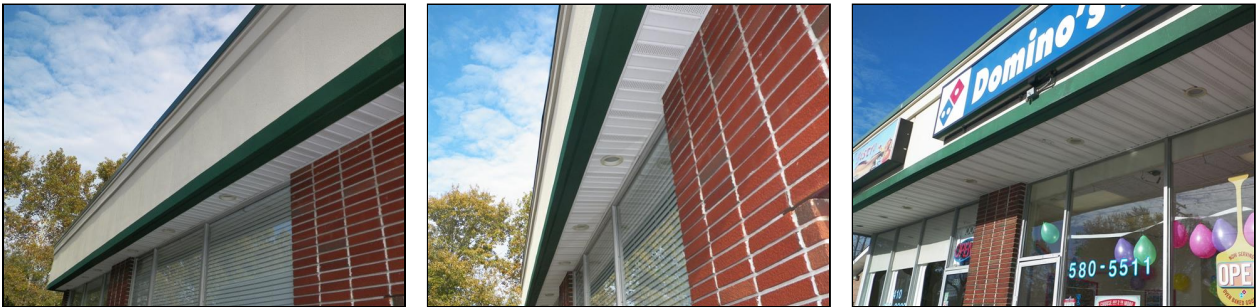
D. Several high building exterior surfaces appeared to be a recently installed "EIFS" (Exterior Insulation and Finish Systems) or usually called "Synthetic Stucco" or similar material. BIS did not perform a test for possible water intrusion, as this is a separate test and contract.

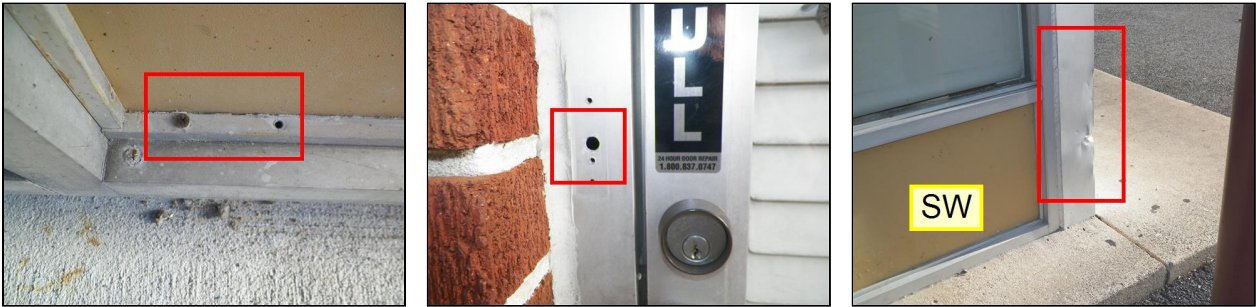
E. (1) The predominant windows were of the storefront type associated with the tenant entry locations along the front/south and west side of the building. Windows were plate glass in aluminum frames. Caulking appeared to be complete, however several openings were observed that need to be sealed to minimize water intrusion. Observed aluminium framing at the southwest building corner was damaged after being hit by a vehicle or heavy cart. Observed two protective pipe bollards were installed adjacent to this location to protect corner from further damage.

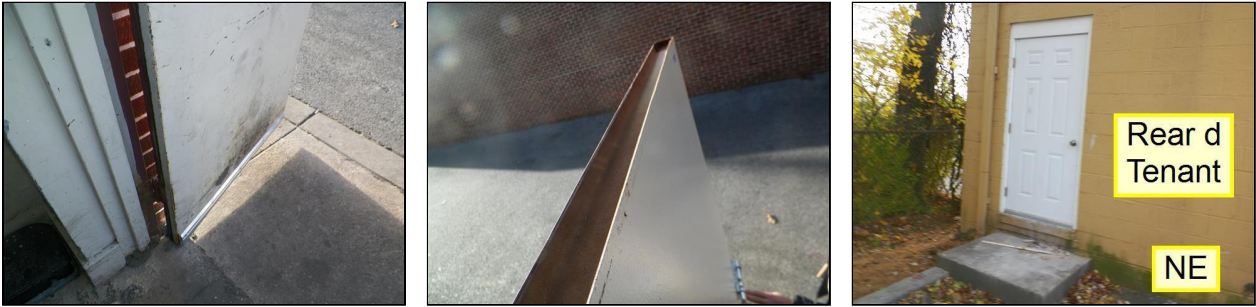
E. (2) The tenant entry doors were part of the storefront system. Doors were single glazed plate glass in aluminum frames. Hardware typically consisted of a pull plate outside, a push plate inside a panic bar inside and keyset. Utility room and rear (north) egress doors consisted of hollow metal doors in metal frames with knobs and standard keysets. Doors typically swung outward and were three feet wide. None of the doors appeared to be fire-rated. Utility room exterior door appeared to be deteriorated/damaged and needs replacement in the near future.

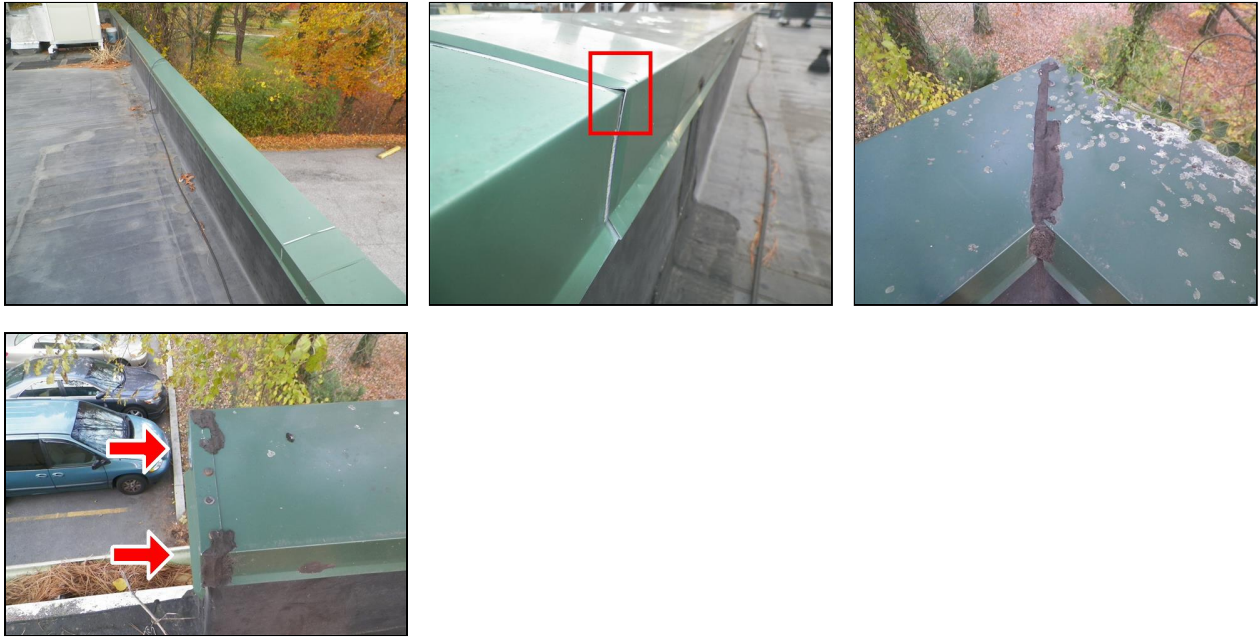
F. The masonry walls extended past the roof surface elevation and formed a perimeter parapet wall. The wall's top surface was covered by sheet metal coping. Observed openings in the overlapping pieces of the coping material, exposed fasteners and mastic material. Mastic deteriorates and shrinks over time thus causing potential openings hence water intrusion possible locations. Recommend the roof installer be contacted to seal openings/nail heads and other necessary items.

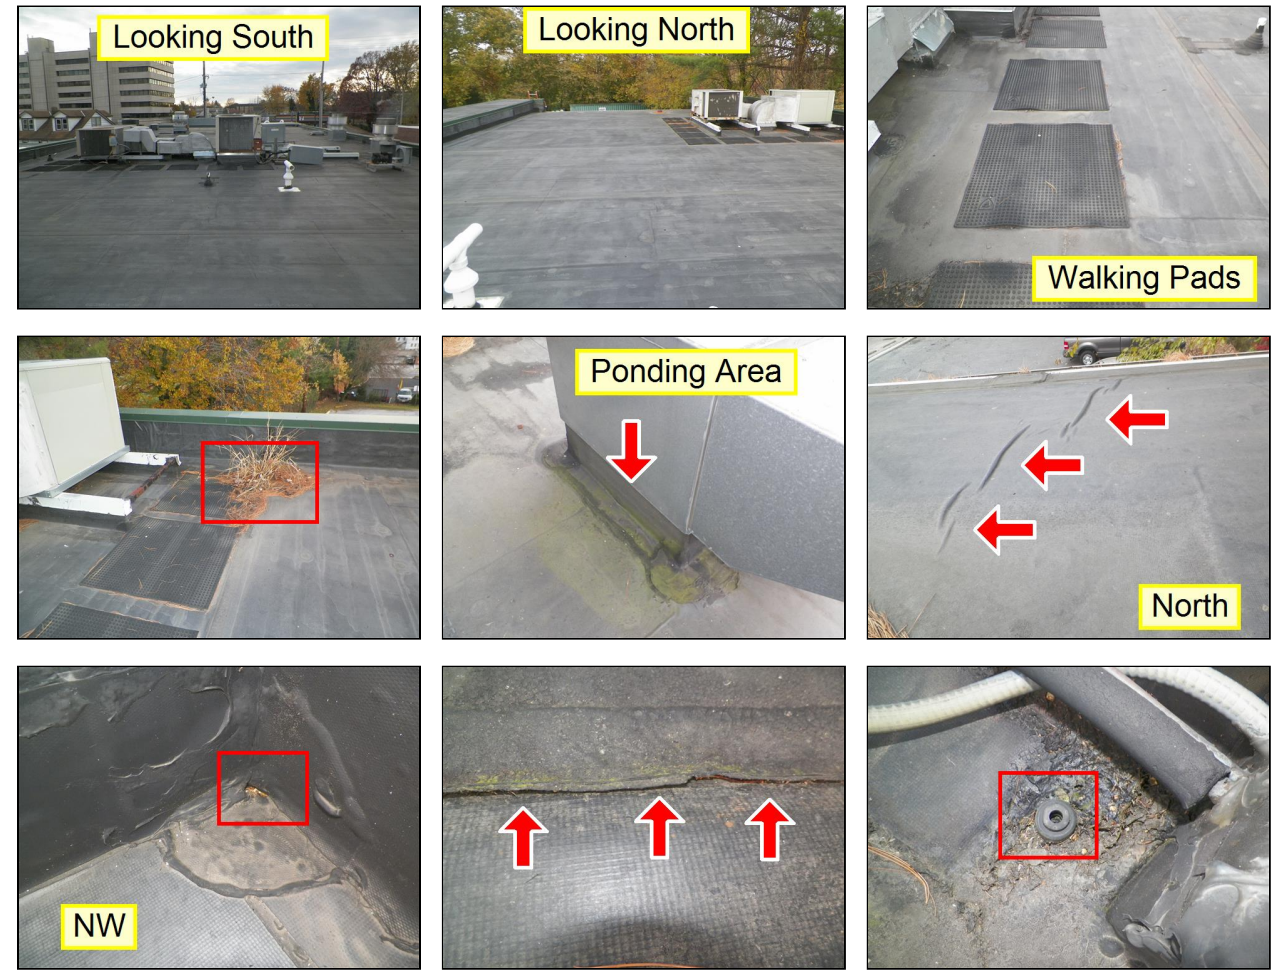
G. The flat roof (less than 3:12 slope) consisted of a built-up roof covering. According to the realtor's listing information the built-up roof covering was installed in 2009 and has a 15-year warranty. Client needs to verify that the roof warranty will continue with the building change of Ownership. According to Garland roof representative, Todd Holtzner, roof warranties normally do not transfer to another Owner. Observed a series of rubber walking pads around the roof-top equipment. The roof covering had multiple roof openings, ponding and other small locations that need to be repaired/replaced (see Photos 4 to 9). Observed a series of wrinkles along the north roof area that may indicate a possible manufacturer/installation defect (see Photo 8). These areas will eventually blister and the roof will need replacing. Recommend roof installer be contacted to repair/replace identified items and others as necessary.

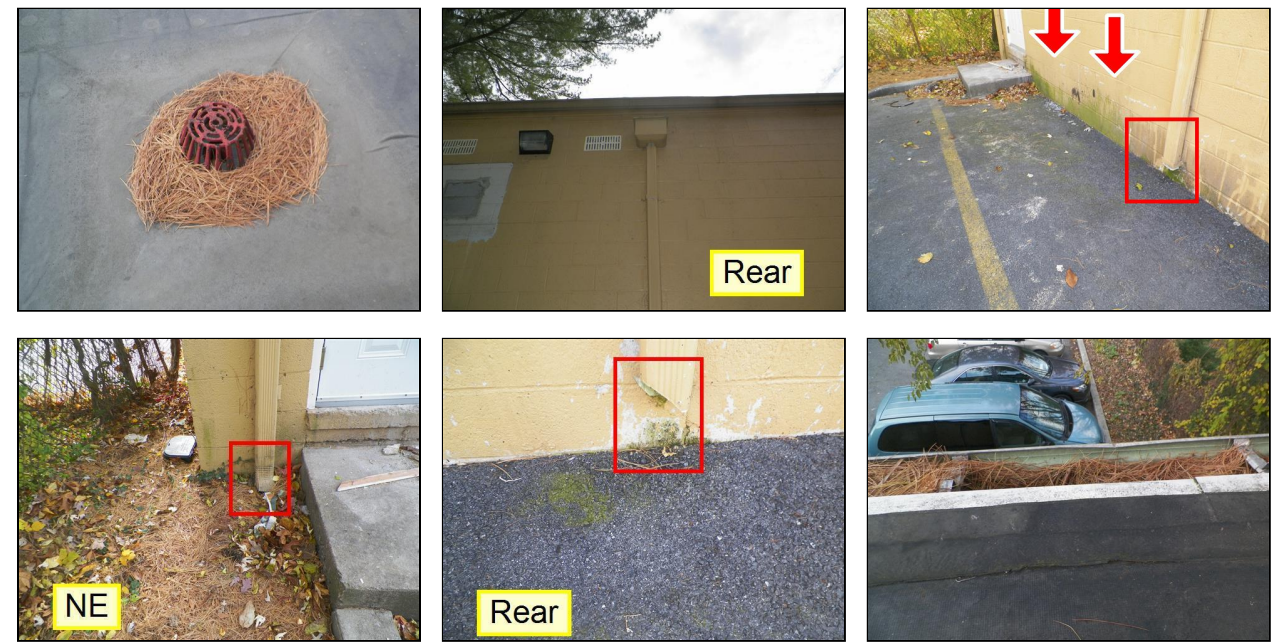
H. Observed a primary roof drain and scupper box at the north central area of the roof (see Photos 1&2). Also observed a gutter running along the north roof edge that discharged storm water through two downspouts. Each downspout lacked a lower elbow and splash pad and allowed water to collect at the foundation wall (see organic "green" discoloring on the rear wall in Photo 3). Note gutter and roof drain were clogged with pine needles. Recommend installation of a gutter shield system and an underground pipe system that would collect storm water from both downspouts and discharge the storm water over to the depressed golf course grassy area east of the property.

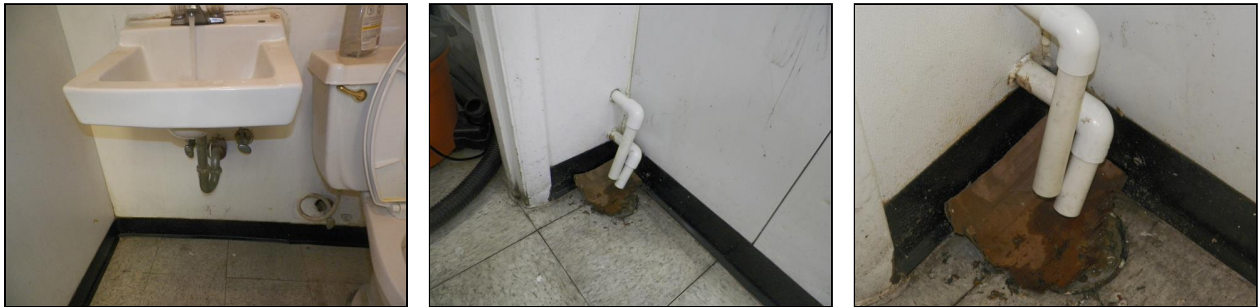
B. (1) Observed drain plumbing and traps underneath restroom and kitchen sinks. Tenant a (Domino's Pizza) had at least two plumbing leaks between pvc fixtures.

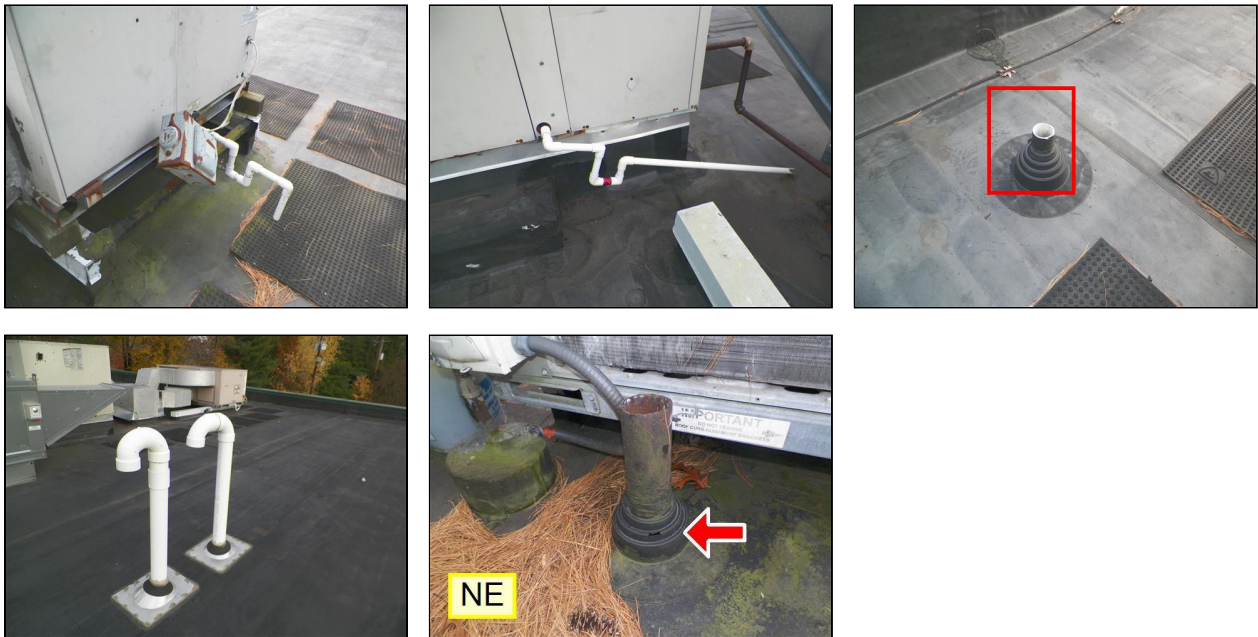
B. (2) Roof contained roof-top unit pvc condensate drains and pvc plumbing stack vents. A very short (damaged?) plumbing vent beside a RTU was observed (see Photo 3). Also observed a damaged plumbing stack boot (see Photo 5). Both items should be repaired as needed.

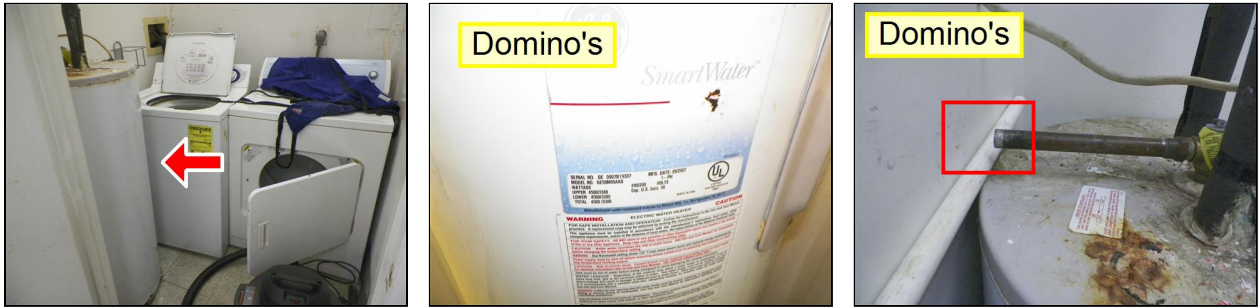
C. (1) Tenant a (Domino's Pizza) contained a GE water heater manufactured in September 2007. Ran hot water and verified hot water existed. Water heater lacked proper pipe to extend within 6 inches of floor for safety purposes (PVC is not approved for hot water use). Recommend installation of pipe by a qualified person.

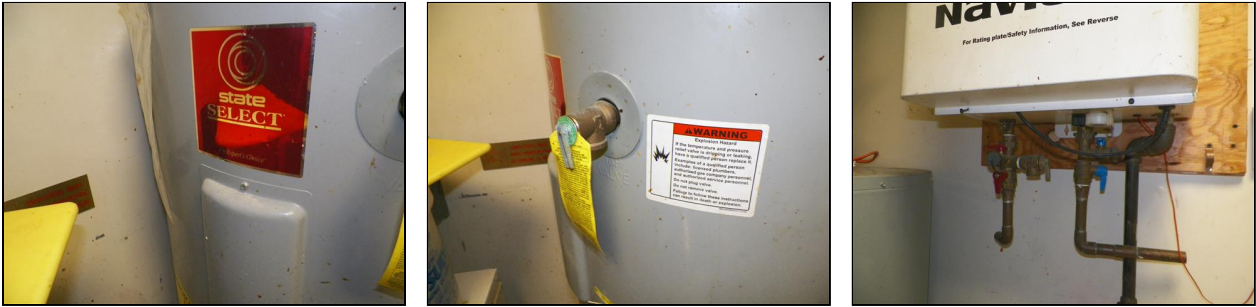
C. (2) Tenant b (Silk Road Bistro) contained a State Select water heater. Manufactured date is unknown but suspect it was installed during tenant fit-out in 2010. Also contained an abandoned Navien tankless water heater on the adjacent wall. Ran hot water and verified hot water existed. Water heater lacked proper pipe to extend within 6 inches of floor for safety purposes (PVC is not approved for hot water use). Recommend installation of pipe by a qualified person.

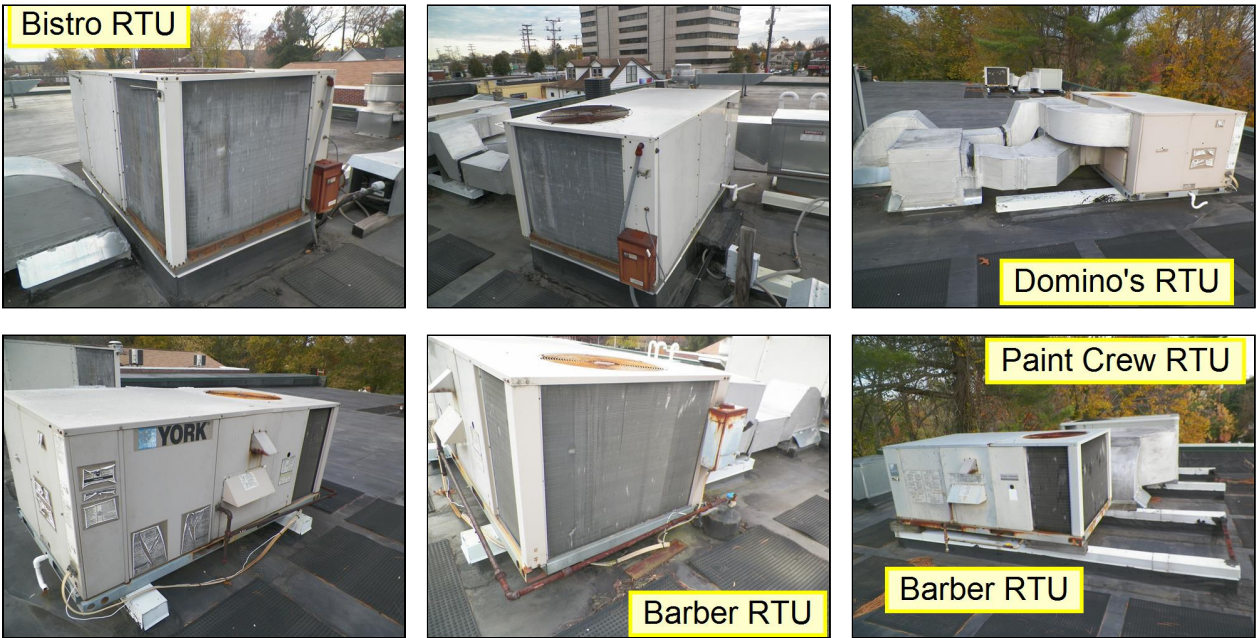
D. (1) Roof-top units provide heating and cooling for each tenant. BIS did not operate any thermostat or other equipment to prove which unit was serving which tenant; however the RTU physical location normally indicates the served location. While several units were replaced since 2000, tenant b and c appear to be aged and may require replacement in the not too distant future.

Tenant d - a gas-fired Trane RTU appeared to serve Painting Crew - model #YSC036A3EHA000, serial #727101686L represents a 3-ton convertible unit manufactured in June 2007.

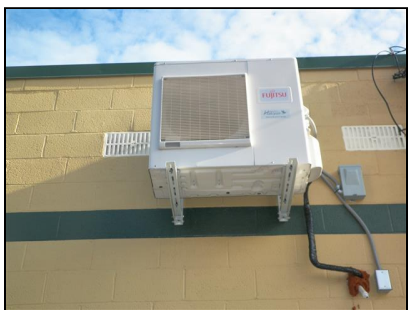
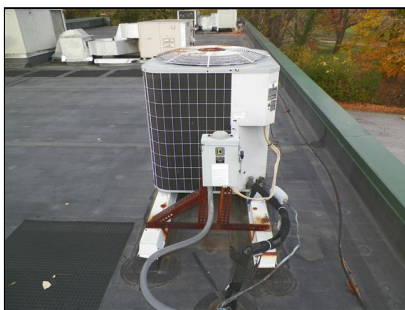
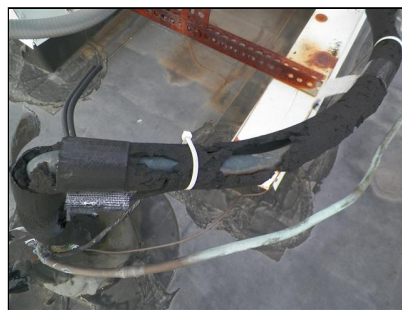
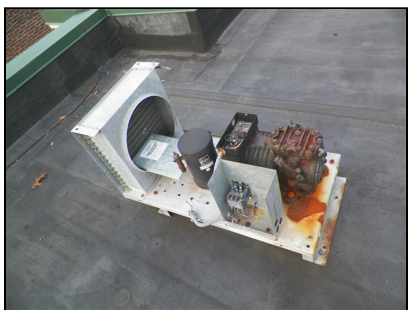
A Carrier A/C unit (see Photos 3&4) model #1505E27604, serial #38CHC060570 appeared to serve tenant a (domino's) with cooled-air. Unit appeared aged even though according to its serial number was manufactured in May 2005 Recommend replacement of the suction line foam insulation.

What appeared to be an abandoned A/C unit (served the former restaurant) existed and needs to be removed and roof penetration sealed (see Photo 4).

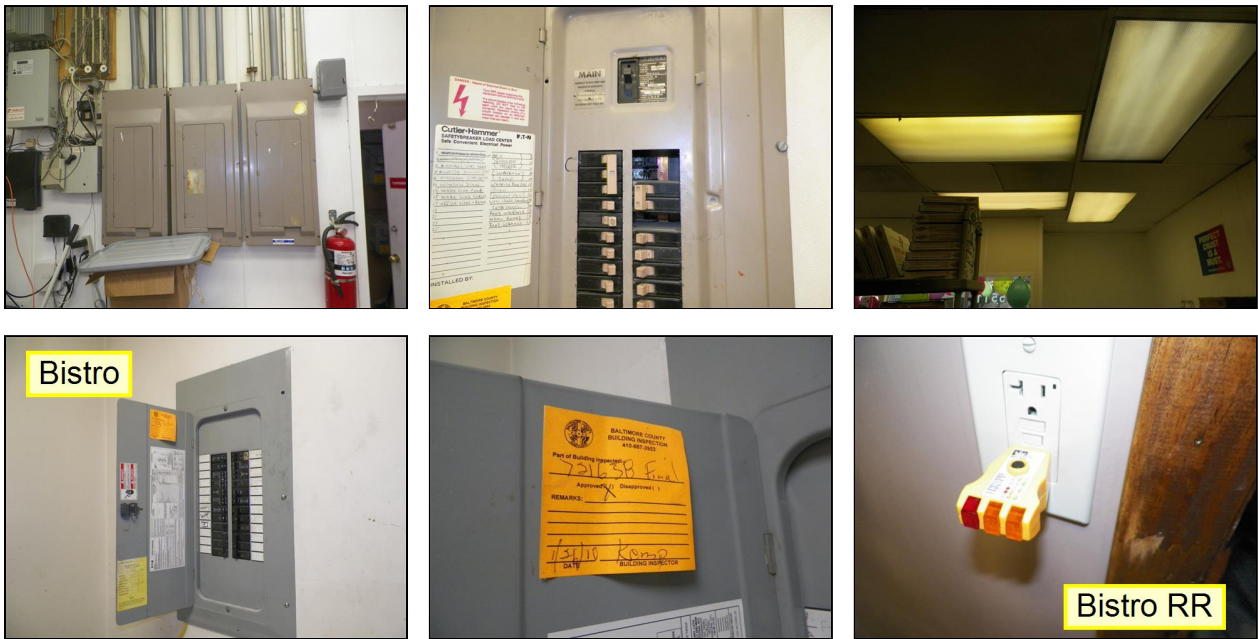
G. (1) Building had interior Square D panels and sub-panels, wiring and devices installed in accordance with typical retail spaces. Tenant a (Domino's Pizza) contained three Square D circuit panels inside their space. A representative of accessible outlets were tested with the circuit tester. Interior lighting consisted mainly of recessed 2 by 4-foot fluorescent fixtures, which appeared to supply adequate interior levels of visited spaces.

Tenant b (Silk Road Bistro) appeared to contain recent electrical distribution panels, outlets and switches. Note Baltimore County inspector signed panel permit on January 2010. Recommend further evaluation by a licensed electrician on why GFCI in men's restroom did not operate when tested (see Photo 6).

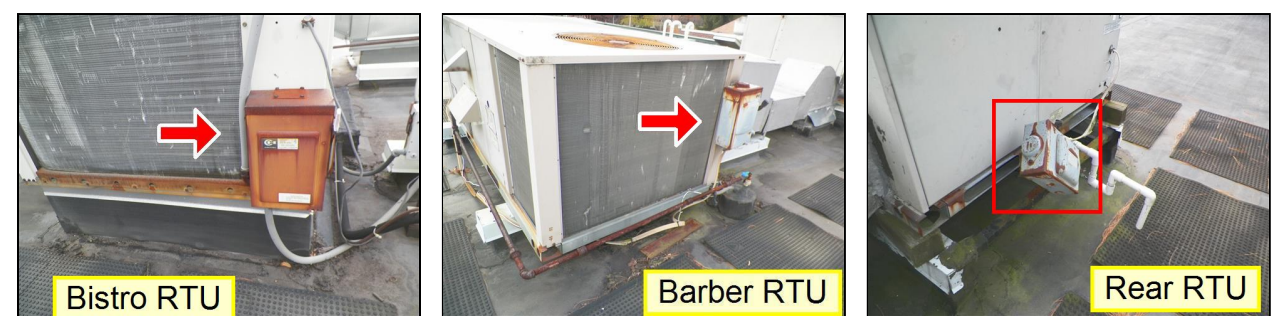
G. (3) The electrical distribution shut-off Cutler Hammer boxes and their connections were severely deteriorated at least 3 RTUs. Recommend replacement.

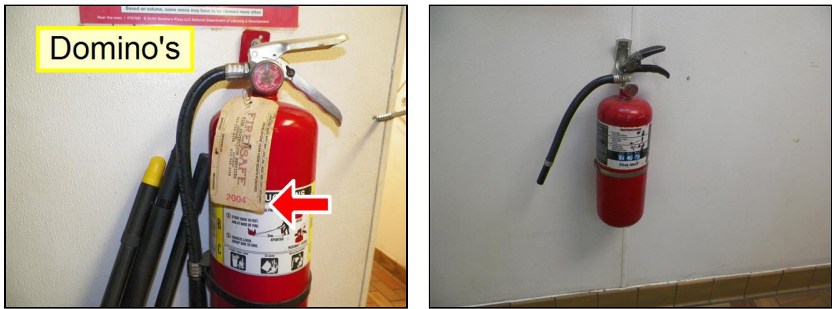
D. Portable fire extinguishers were observed throughout. Note Photo 1 the service date was listed as 2004. Client should keep in mind that all fire extinguishers must contain 2013 certification.

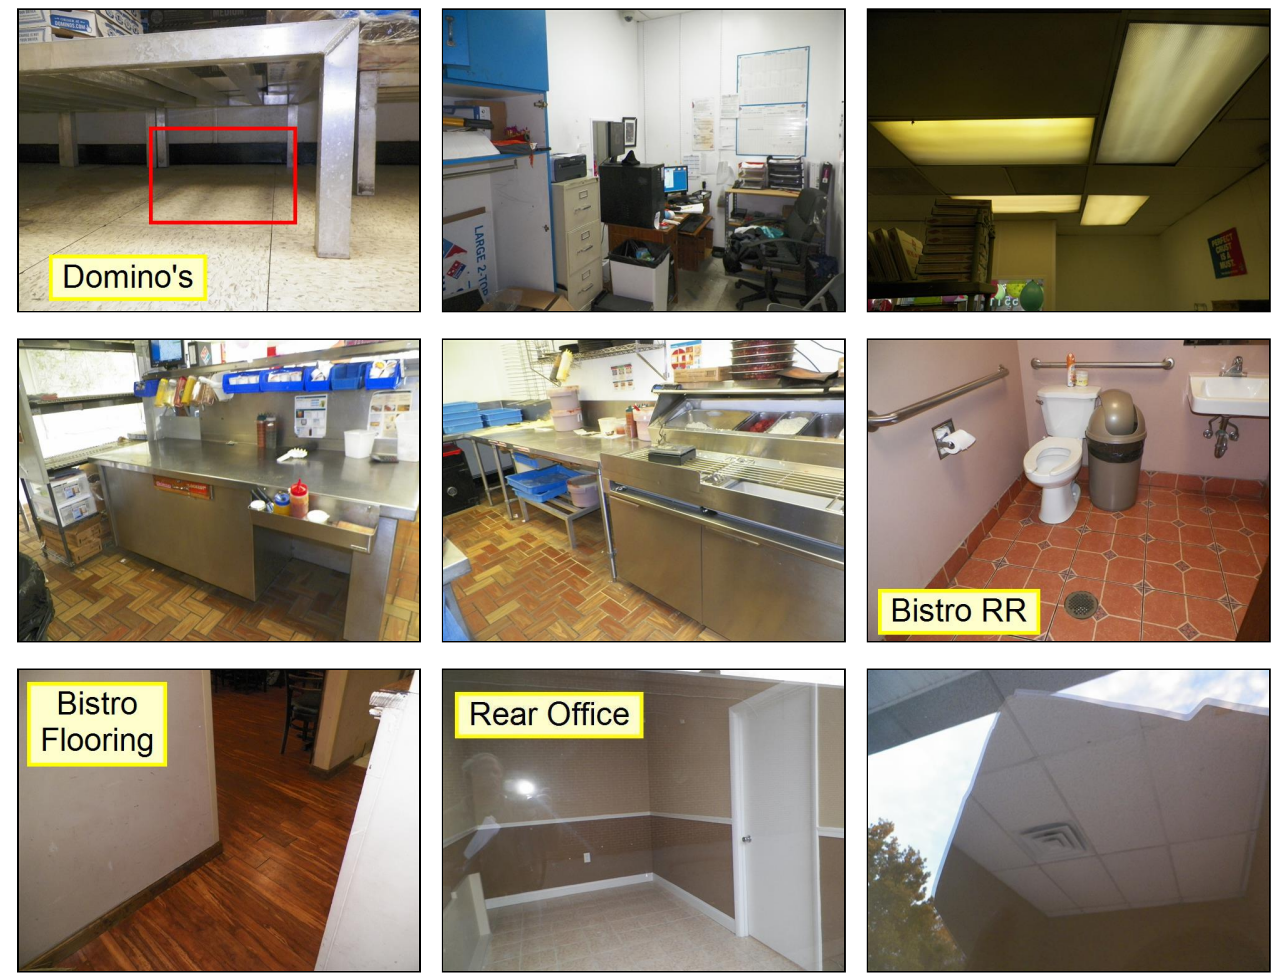
A. A variety of interior spaces for the 4 individual tenants existed in the building including retail, kitchen, eating, food prep, barber, offices, washer/dryer room, utility and restrooms. Typical interior surfaces included a suspended acoustical tile drop ceiling, tenant demising walls were drywall over wood studs and wood/vinyl/ceramic tile floors. Evidence of a leak between the front tenants under a demising wall at location in Photo 1 was observed.

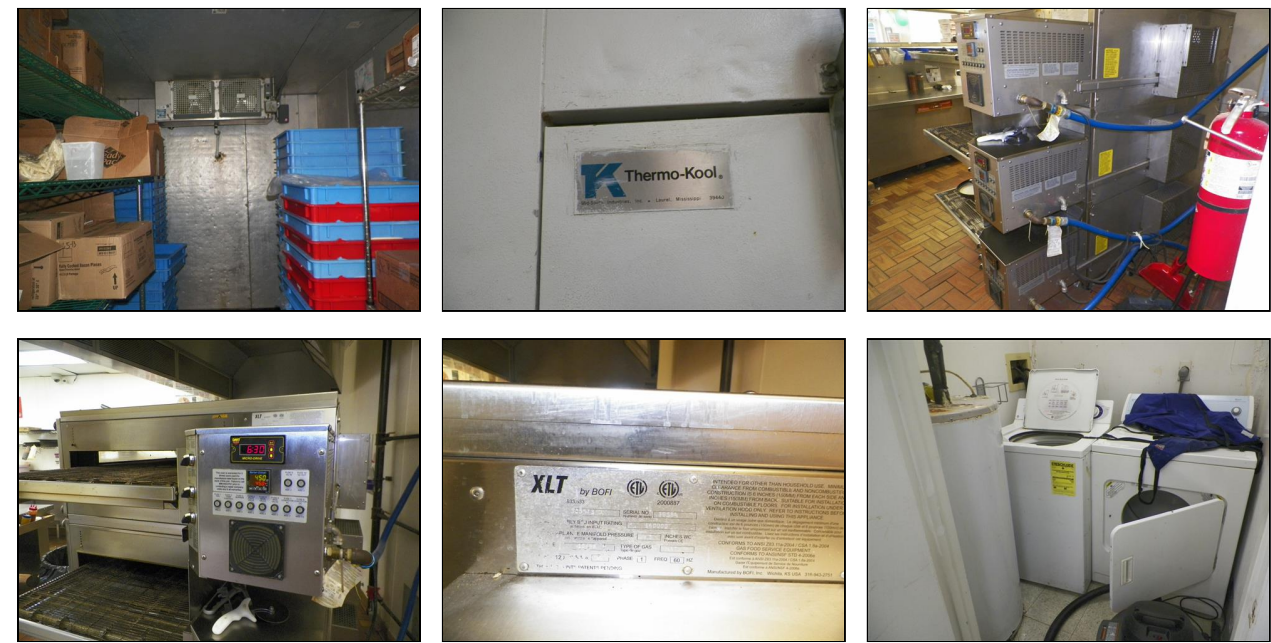
C. (1) Tenant a - Domino's Pizza had several large equipment items that were not evaluated - refrigeration unit, ovens, and washer & dryer. Observed that dryer vent was not connected to the vent system and was probably allowing lint to be released into the building. Lint build-up could potentially become a fire hazard; recommend dryer be connected to an exhaust system that discharge to the exterior (observed a dryer exhaust cover on the east wall).

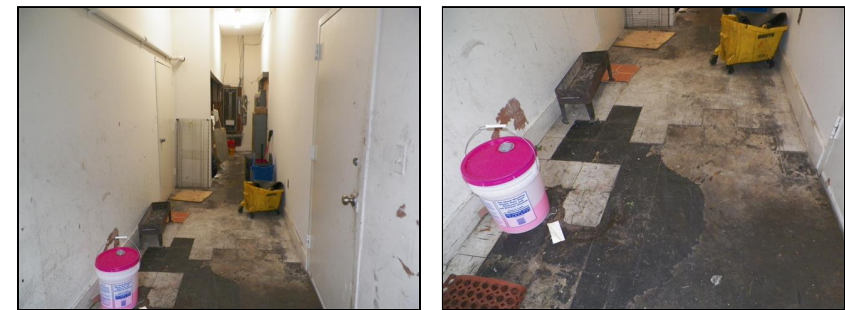
A. An utility room separated the front two tenant spaces from the rear two spaces. Same typical surfaces were observed as the interior spaces: drywall walls, drop ceiling and tile flooring. The age and size (9" x 9") of the utility room tile indicates that it may contain or be glued with an asbestos-type material. The tile material appeared to be intact, however a portion of the room lacks tile. Asbestos main health concern is when the material is "friable" (crumble/break apart) and the air-borne particles can be breathed. Also asbestos should only be taken to an approved landfill site. Recommend Client have the material tested and evaluated by a specialist and take the corrective action they recommend.
