# Inspection Report

**Property Address:**  
1234 Main Street NE  
Washington D.C. 20019

## **Barnes Inspection Services**

## EXECUTIVE SUMMARY

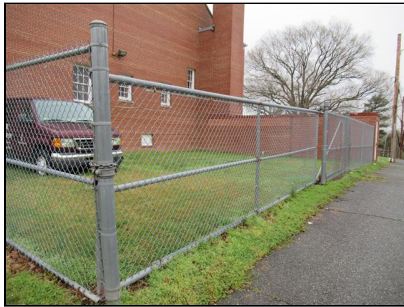
F. (4) Observed a secure grassy parking area with chain-link fence and a sliding gate.

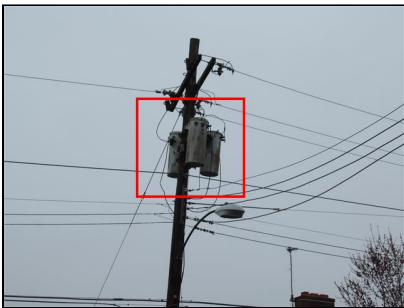
B. The source for electricity is Potomac Electric Power Company (Pepco) that originates at a pole transformer across Minor Street.

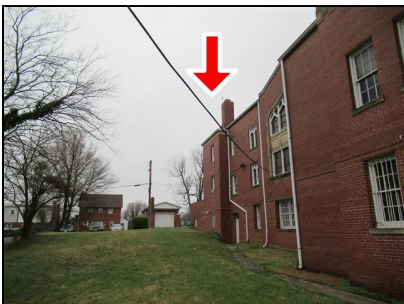
F. Low hanging Bell Atlantic telephone wires were observed along the east side of the building from a Main Street utility pole. Recommend the wires be raised for safety purposes.

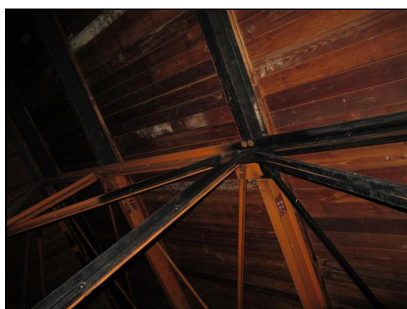
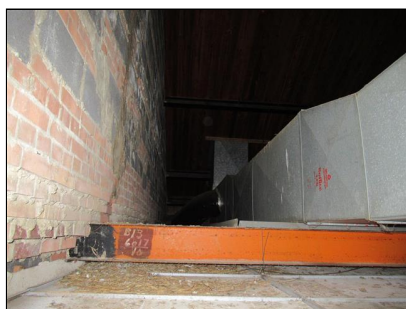
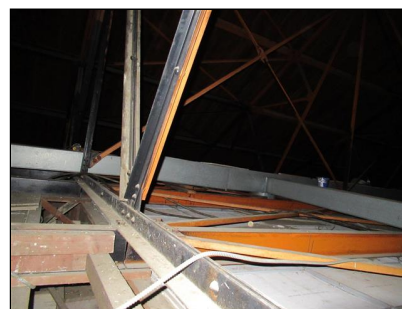
**B.** The limited observed basic building structure included concrete masonry unit (CMU) and brick load-bearing exterior walls, steel roof trusses, common board sheathing, interior concrete (lower level) and steel (upper levels) beams & columns that support a metal deck and interior finishes. Interior walls are plaster applied over a wood lath. Gravity and live loads are taken through this system to the foundations. Lateral, wind load and stability are provided through the shear action of the masonry walls in combination with the concrete/metal floor and roof frame design. Although analysis of the structure is beyond the scope of this report, BIS can state that the loads imposed on and by the structure do not appear to have imposed any current or long lasting physical deformation. BIS judges the structure to be sound overall.

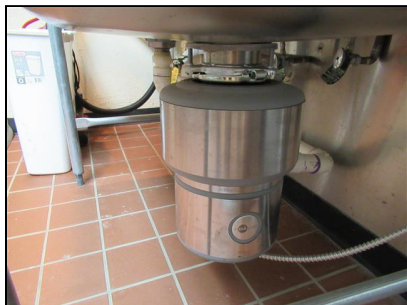
**B. (3)** Observed that the kitchen contained a below sink food disposal appliance manufactured by In-sink Erator that operated during the inspection.

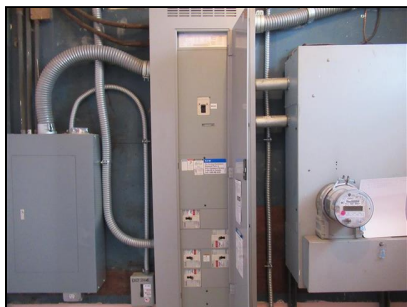
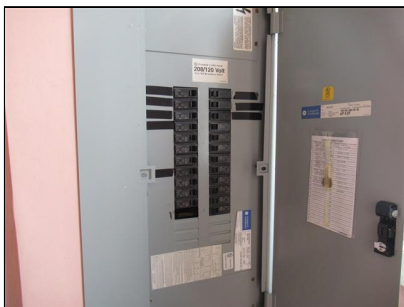
F. Potomac Electric supplies electric service to the property. Observed an exterior pole transformer across Minor Street feeding overhead conductors across to an utility pole drop then underground into the building. An interior meter, 400-amp capacity load center and 225-amp electric panel in the lower level electric room. The load center is listed a 208/120, 3-phase, 4 wire service. Service is then supplied separately to the sanctuary and support sections of the building. Connected electric panels varied in size from 100- to 225-amps. The main electric equipment was installed in 2012. Electrical equipment appeared to be in good to fair condition.

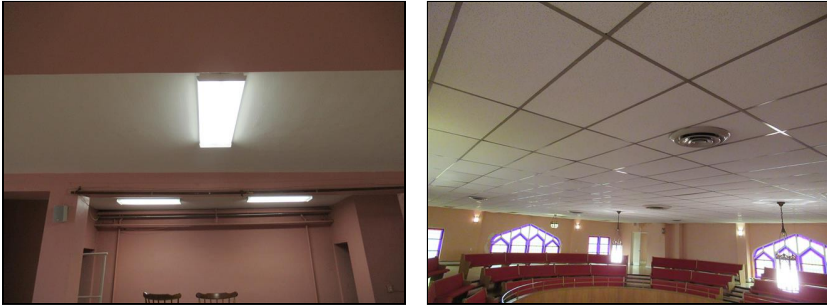
G. (2) Interior lighting consisted of a variety of ceiling and wall fixtures that included recessed 2- by 4-foot fluorescent ceiling fixtures, and hanging ceiling fixtures. Light fixtures appeared to supply adequate levels of lighting throughout the building.

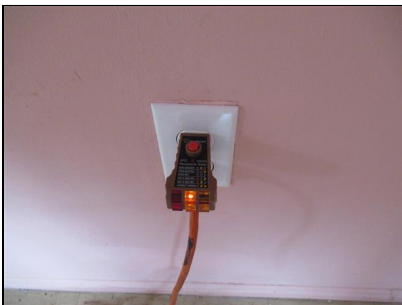
G. (4) At least four not grounded outlets were observed using the circuit tester during the inspection. Locations are mostly in the lower level - left of stage, northeast vestibule, and two in southwest office. Electrical issues are considered a hazard until repaired. A qualified licensed electrician should perform repairs that involve wiring.

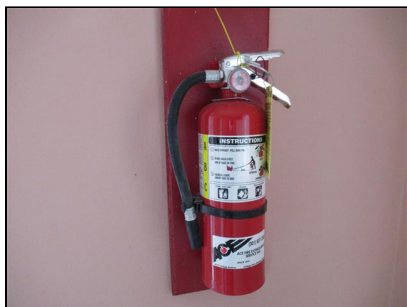
**D.** Portable fire extinguishers were located throughout the building with a September 2019 service date completed by Ace Fire Extinguisher Service (301-927-7300). Client should have maintenance contractor service the extinguishers before moving in and on an annual basis afterwards.

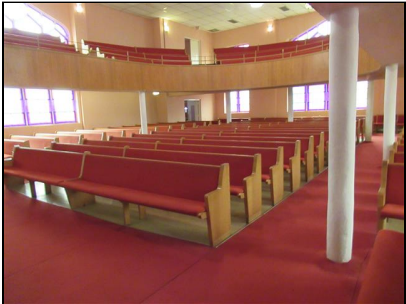
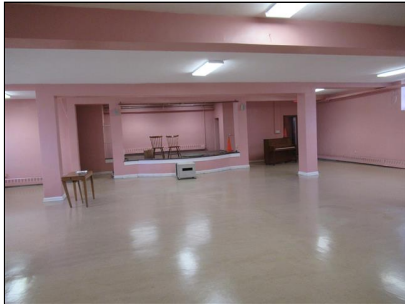
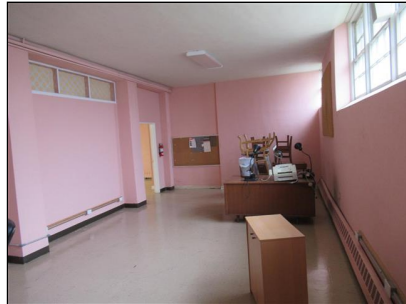
**A. (1)** A variety of interior spaces existed throughout the church and supporting spaces that included a sanctuary, lower level event hall, offices, kitchen, stairways, restrooms and equipment rooms. Typical interior surfaces included plaster or suspended acoustical tile drop ceilings, painted plaster and sheetrock walls, and carpet/tile floor coverings. The several small carpeted rooms will require new carpeting before moving in.

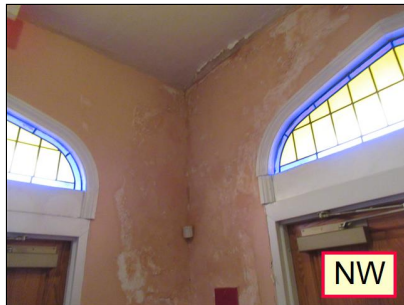
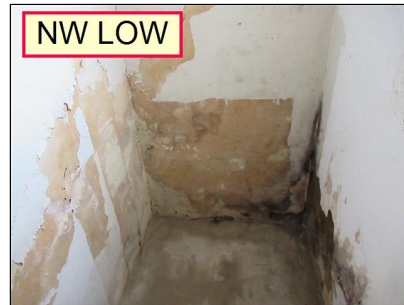
A. (3) BIS observed multiple locations water intrusion throughout the building at three stairways (northeast, northwest and southeast) and along the sanctuary north wall. There may be other locations that were inaccessible or covered by furnishings. Hidden damages may exist. A moisture meter showed signs of elevated moisture (last rain was the previous day) at three active leak locations: 1) above center stained glass window, 2) northeast corner on both side of staircase wall and 3) northwest stair near bell pull rope. Deteriorated plaster wall surfaces existed at each water intrusion location along with water stains. Several of these stains were dark in color and to BIS represented signs of microbial growth. BIS did not inspect, test or determine if this growth is or is not a health hazard. The underlying cause is moisture or dampness. Recommend you contact a mold inspector or expert for investigation and correction, which probably includes removing damages areas, replace the plastic wall materials and exterior sealant/re-pointing as described in Section 4.

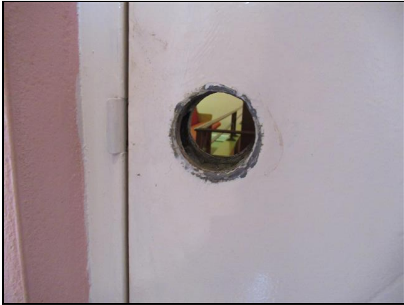
B. (2) Observed an interior door missing hardware leading to the choir loft. Recommend a qualified person install the hardware as part of routine maintenance.

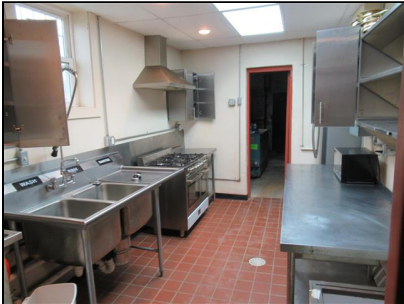
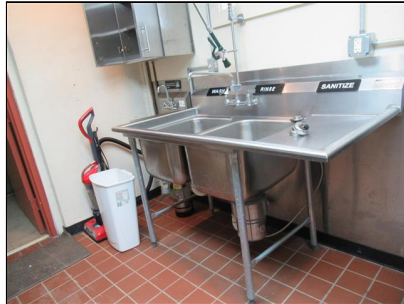
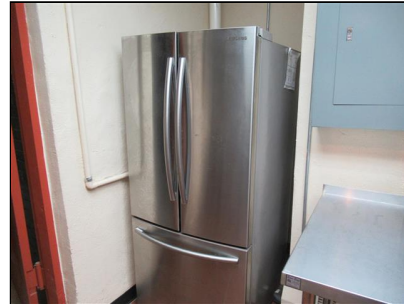
C. (1) Observed commercial kitchen equipment at the southeast corner of the building. Kitchen equipment included stove-top with exhaust hood, microwave, refrigerator, double sink, stainless steel sinks and counters. BIS did not operate any equipment during the inspection.

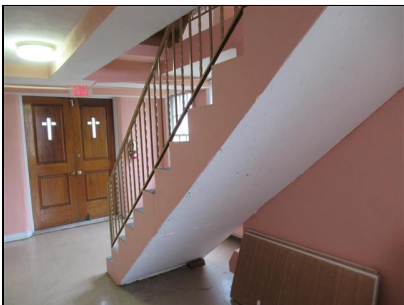
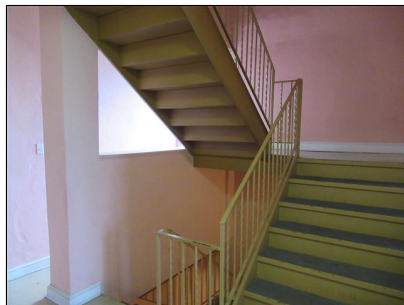
C. (2) Observed four sets of stairways, basically one at each building corner. The stair section to the lower level was concrete framed; upper stair sections were metal framed. Stairs had concrete in pans topped with rubber treads. Stairs had metal handrail components. Stairway walls contained damages from water intrusion, which was described in more detail in Section 7.A.(3).

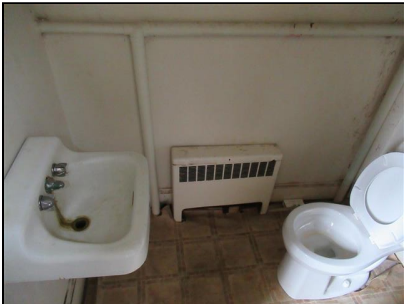
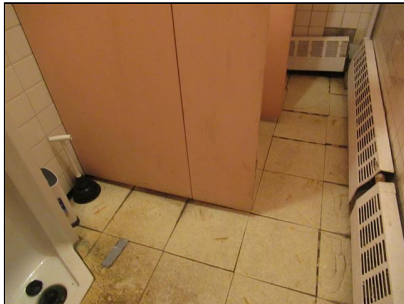
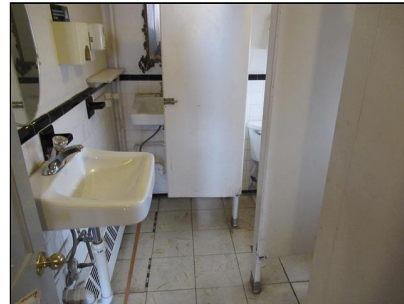
C. (4) A total of five restrooms existed in the church building: two on the lower level, two on the sanctuary level and one in the pastor's office (Photo 1). The four main restrooms contained commercial fixtures in a basic 6 foot by 8 foot footprint with very little circulation to pair of toilets and sinks (Photo 2&3). Each restroom main had loose flooring tiles. The pastor's restroom contain a small residential style sink and toilet. Recommend all restrooms be renovated and enlarged.

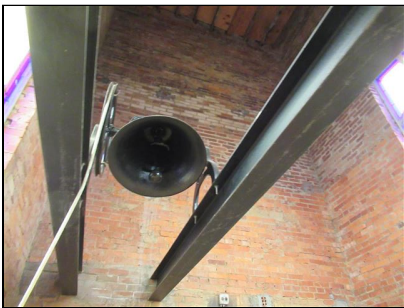
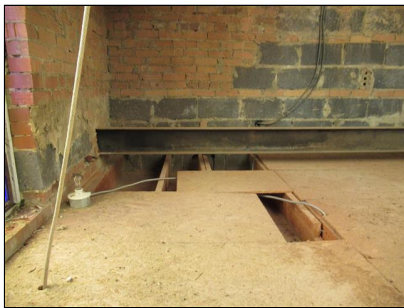
C. (5) BIS accessed the bell tower above the northwest stairwell and noted superstructure conditions.

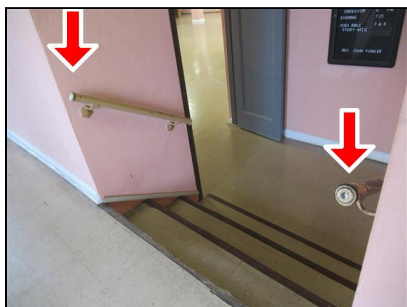
C. (7) Several interior stair handrails have relatively sharp edges. Client should turn all open handrail ends toward the wall as a fall or injury protection.

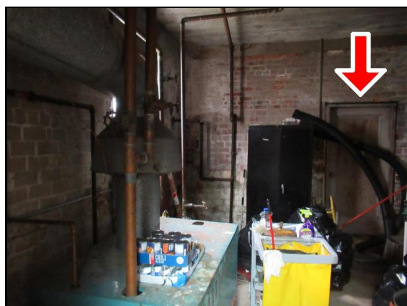
C. (8) BIS did not access the rear egress corridor since the indicated door was locked during the inspection.
