Inspection Report

111 Smith Road
Baltimore MD 21345

Barnes Inspection Services

Date: 11/12/2013	Time: 02:00 PM	Report ID: 1311.01
Property: 111 Smith Road Baltimore MD 21345	Customer: John Smith	Real Estate Professional: John Doe Colliers International

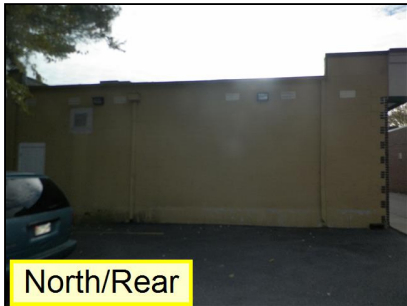
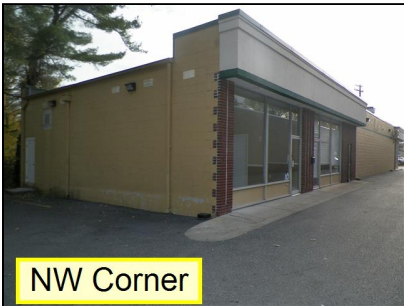
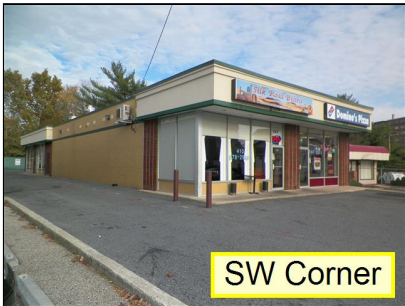
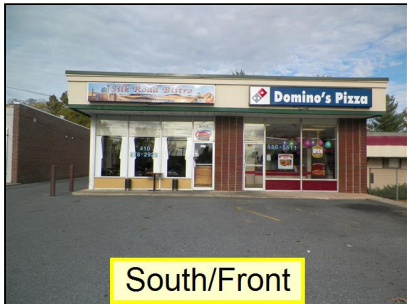
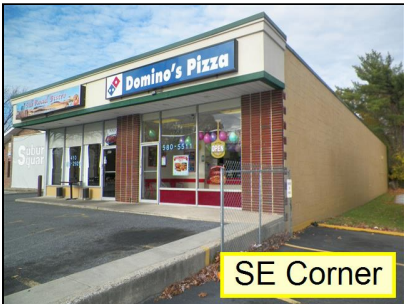
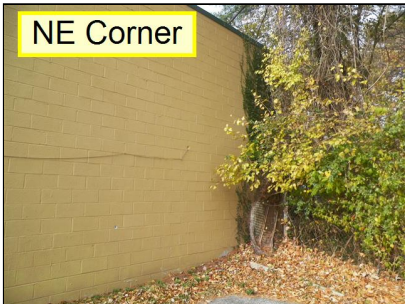
A. The property was generally flat with a high-elevation contour location as indicated on Photo 1. Pavement slopes both toward the front (Smith Road) and rear east (golf course). Parking and service drive pavement appeared to be properly sloped to discharge storm water onto Smith Road and onto two rear curb cuts. Property mainly consists of building and asphalt pavement. Observed a slight negative slope to the grassy area along the east exterior wall (see Photo 3). This area should be raised to provide positive drainage (1" per foot) away from the foundation wall.

D. (1) Asphalt pavement surfaces appeared to be recent and were generally in tact. Only observed a surface crack running along the middle of the service drive (see Photo 3). Concrete curb outlined the rear parking pavement and was found to be in good condition. Recommend all cracks be sealed on a regular basis to minimize water intrusion into the pavement section.

E. (1) The pedestrian paving consisted of concrete sidewalk along the front and west side of the building and along Smith Road. It appeared a private or public agency had recently completed construction along Smith Road fronting the property and had not replaced the removed sections of sidewalk. Note Miss Utility markings on Photo 1. Client should verify that others will re-install front sidewalk sections or he may have to. Several on-site sidewalk cracks need to be sealed to prevent further deterioration from water intrusion. As stated in 4.D.(2) the ADA accessible route had a 1" to 2" elevation difference between the pavement and sidewalk surface therefore requiring a small curb cut to be installed (see Photo 3).

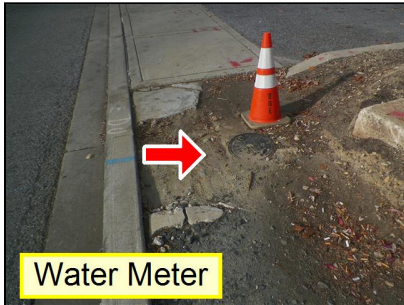
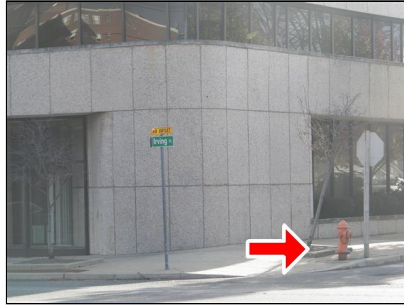
A. Water service is supplied off a 12" main along Smith Road by the Baltimore County Department of Public Works. Service records are maintained by Baltimore City DPW and according to John Watford, City Water Engineering representative, 111 Smith Road is served by a 5/8" meter and 3/4" water service. Meter was set in 1974. Mr. Watford stated that the meter seemed one size too small for a 4,800 square foot building with multiple tenants and that there may be a strong possibility for upgrading in the future.

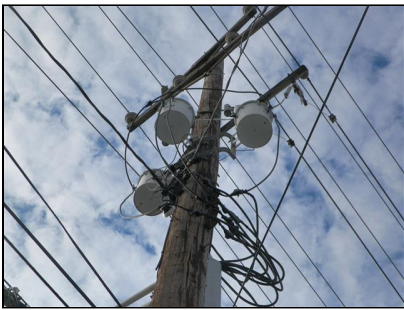
B. Baltimore Gas & Electric (BGE) supplies an underground power high-voltage, 3-phase electric service off a Smith Road utility pole with 3 pole transformers. Underground ductbank runs west along the front of the property then directly north along the service drive and turns right toward the utility room where the electric meters exist. Exhibit D represents the BGE Primary Service plan. According to Exhibit E the BGE Secondary Service plan, the electrical service wire size is "2/4-350AL XLP" meaning that a pair of 4-wire, 3-phase aluminum wires probably in a ductbank run through the site and into the utility room.

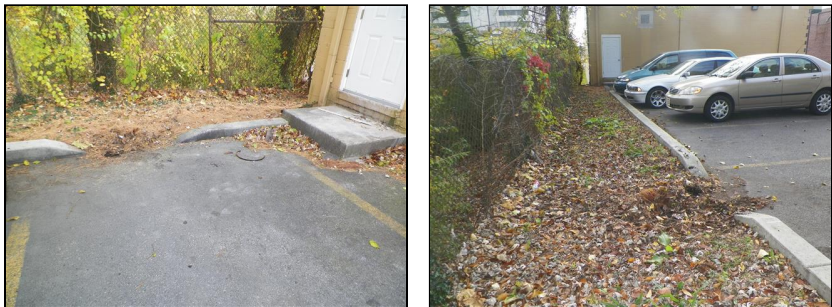
E. It appeared that the property drained in two basic directions from a peak elevation near the northwest corner of the building. All pavement to the south drained by sheet flow onto Smith Road to storm drain inlets along Smith Road and eventually into a Baltimore County 36" RCCP storm drain main along Main Road. Pavement to the north, basically the entire rear parking lot, drained in an easterly direction to two curb cuts that discharge onto a grassy area sloped toward the golf course.

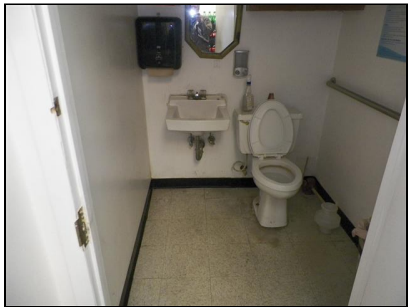
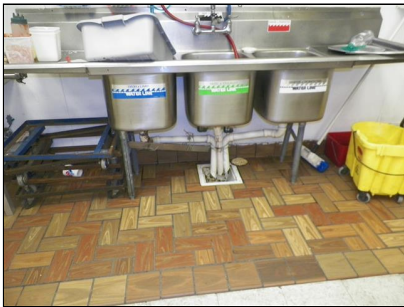
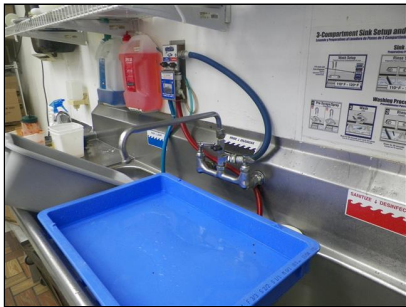
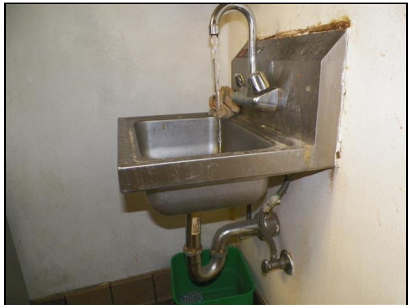
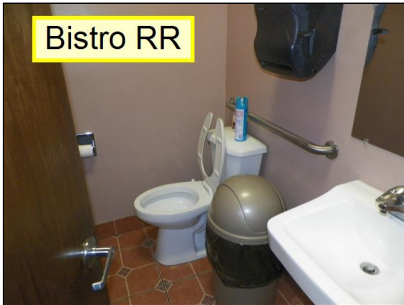
A. The domestic water service ran from the water meter at Smith Road into the utility room and then into each tenant space via what BIS suspects to be copper piping. Tenant a (Domino's Pizza) and tenant b (Silk Road Bistro) spaces contained restroom, kitchen, sinks and other connected fixtures.

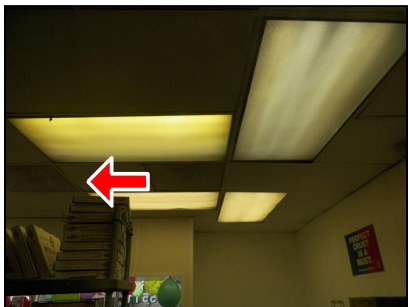
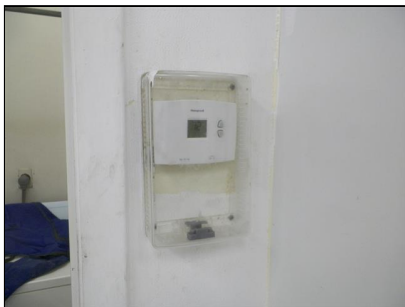
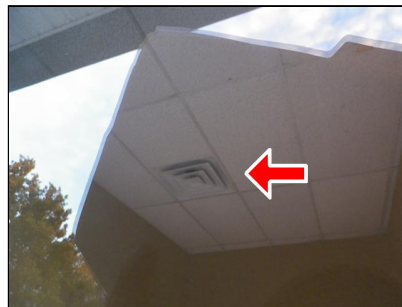
D. (2) Roof-top units provided supply and return air throughout the interior spaces through large ductwork to ceiling diffusers. System was controlled by individual wall-mounted thermostats.

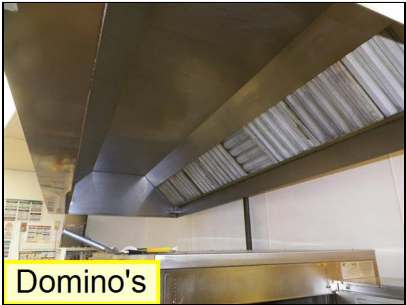
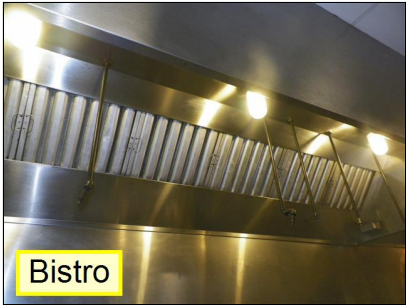
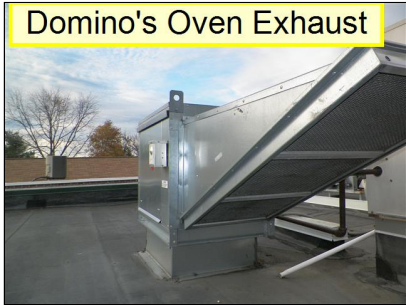
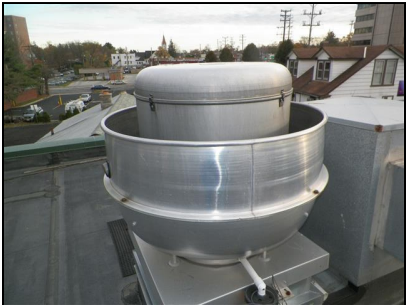
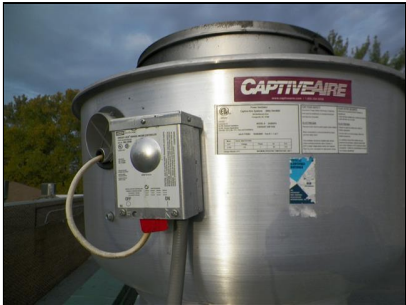
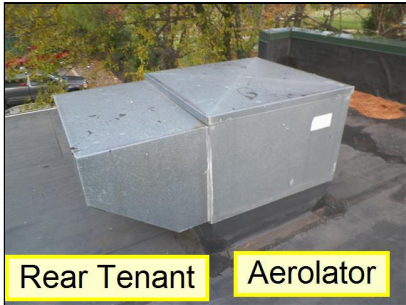
E. (2) Both Domino's Pizza and Silk Road Bistro contained large exhaust hoods over the oven and range areas. Observed connected roof-top exhaust fans. Captiveaire commercial kitchen ventilation system equipment appeared to be of recent age and was operating during the inspection. An older Aerolator (Captiveaire systems) exhaust unit was observed at the north portion of the roof with a serial #II-36818 and 2,000 cfm rating.

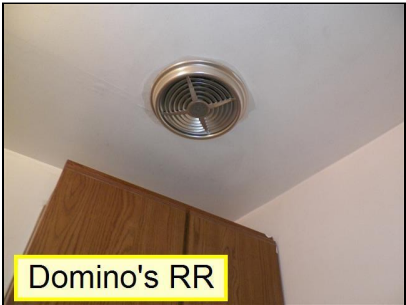
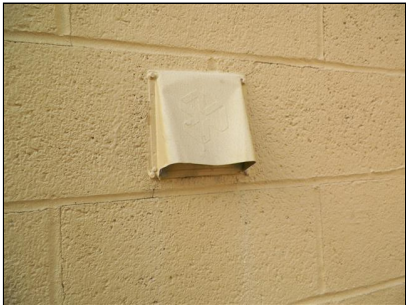
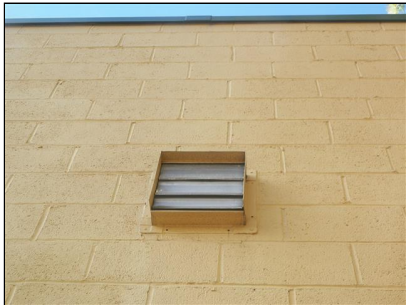
E. (3) Interior bathroom contained exhaust fans that discharged to the exterior.

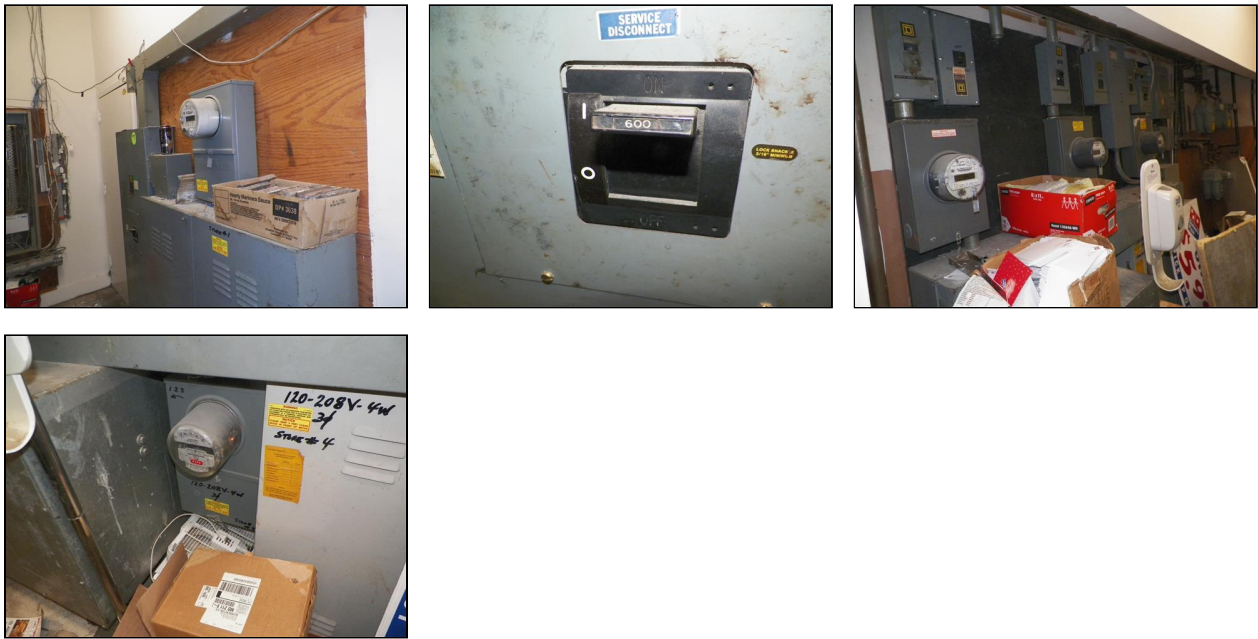
F. Utility room contained a main meter (south wall) and four tenant meters. Store 1 meter listed 600 volts and had a black shut-off switch with a 600 printed on it (600 amps?). Store 2 listed 100 amps. Store 3 listed 200 amps. Store 4 listed 200 amps. Store 1 may be for Domino's that contained 3 individual circuit panels (each at 200 amps would possibly equal the 600-amps). Recommend Client verify this information. Observed main panels were manufactured by Square D and approved by Baltimore County inspector according to panel sticker.

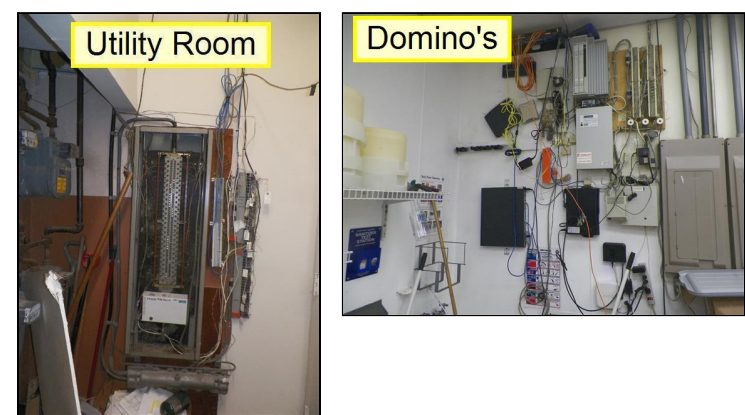
G. (2) A variety of communication (Verizon) devices and connections were located on the rear wall of the utility room and in each tenant space.

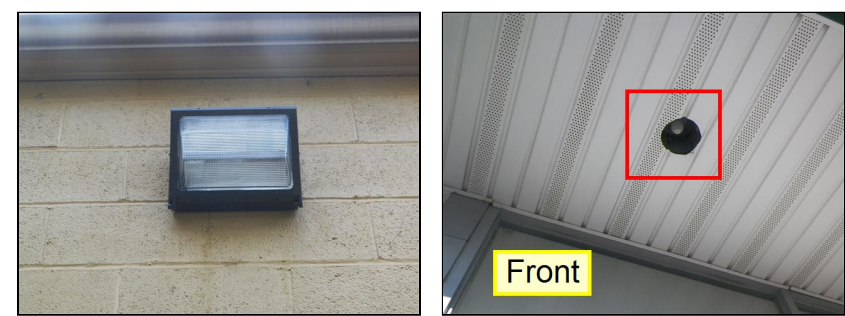
H. Exterior light fixtures for tenant entries, parking lots, service drive and walkways consisted of wall- and ceiling-mounted high-intensity discharge (HID) fixtures on the north, west and south sides of the building. One soffit light fixture at the front of the building lacked a cover. BIS was not on-site during night hours therefore cannot comment on the adequacy of the exterior light levels.

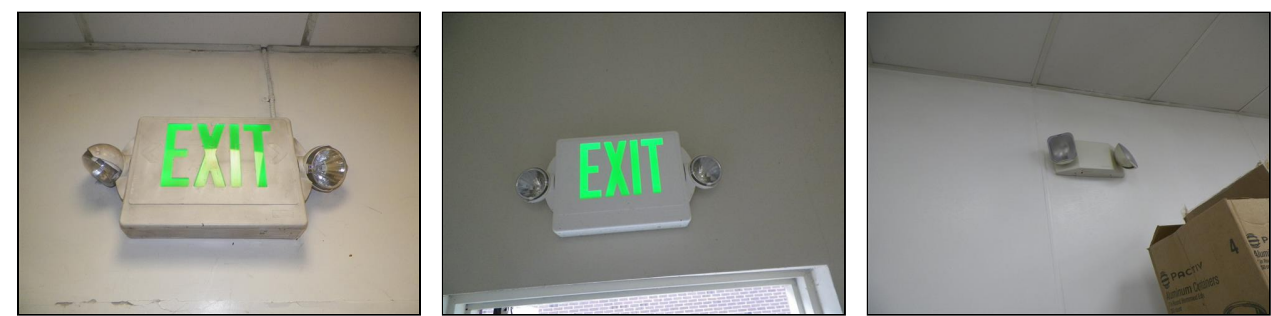
I. Building was equipped with battered-powered "frog eyes" emergency light fixtures throughout the inspected tenant a and b spaces. They appeared to be sufficient in number and location as to properly facilitate emergency excavation.

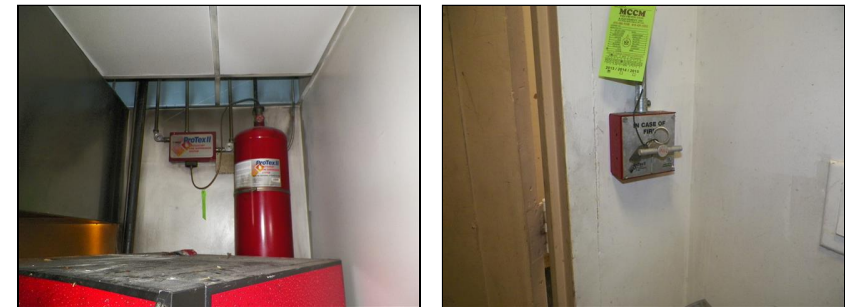
A. A ProTex II restaurant fire suppression system with a "in case of fire pull" station was observed on the Silk Road Bistro.

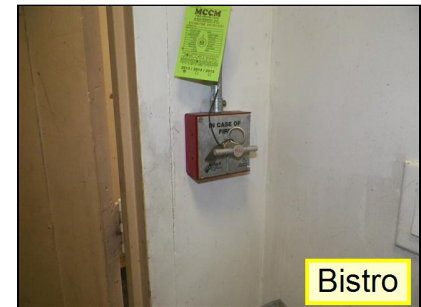
B. Fire alarm pull station for the bistro space and portable fire extinguishers were observed through the 2 visited tenant spaces. The fire suppression alarm system appeared to be operable.

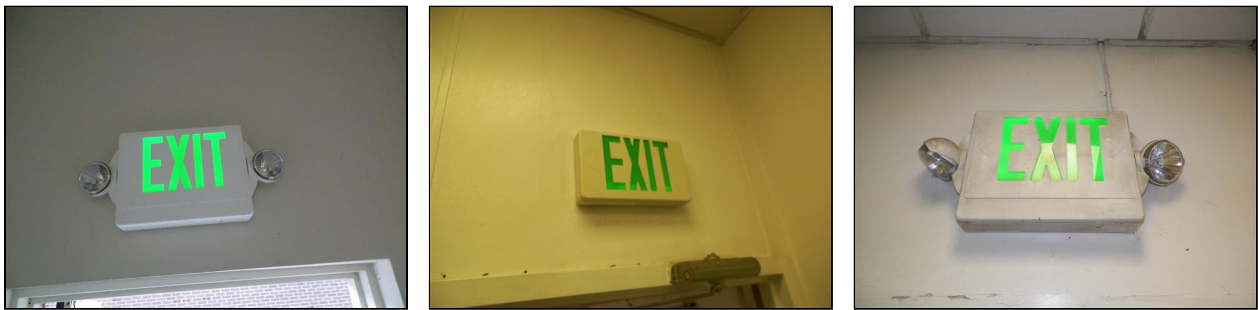
C. Illuminated exit fixtures existed throughout the building.

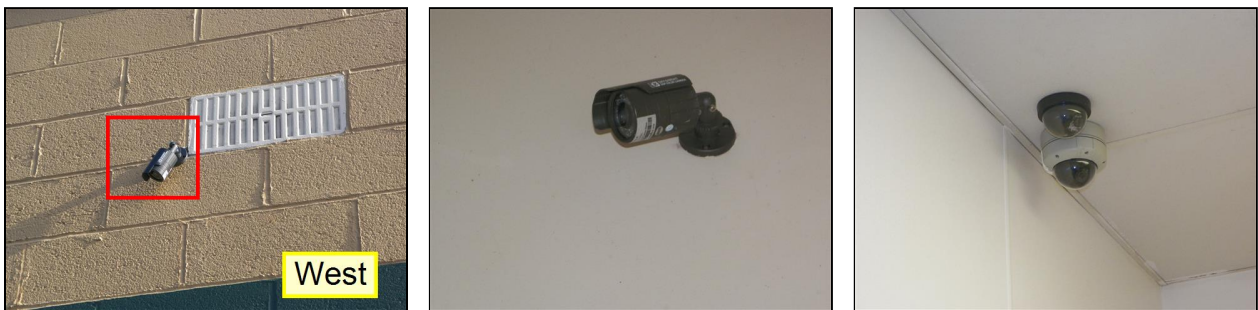
E. Observed a building/tenant space security system with cameras and monitors.

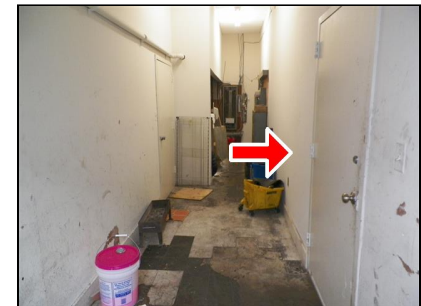
B. Interior doors typically consisted of solid 3 foot wide wood doors. Interior doors did not contain a fire-rated label. No interior windows were observed during the inspection.

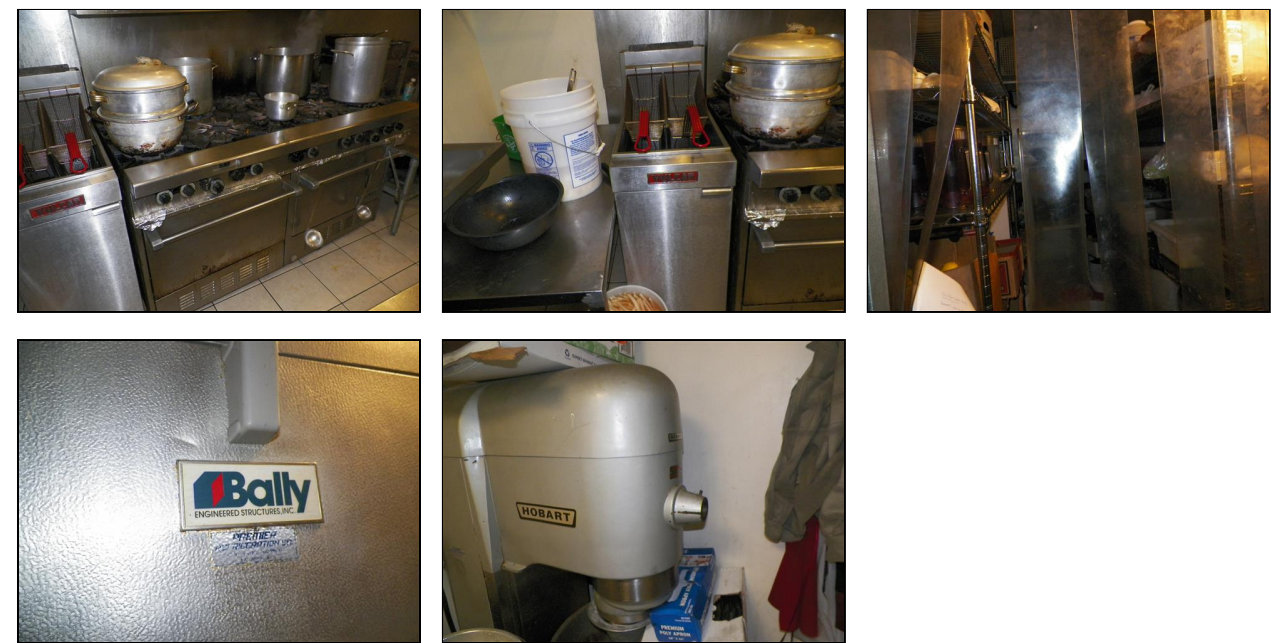
C. (2) Tenant b - Silk Road Bistro had several large equipment items that were not evaluated - refrigeration unit, range, mixer and deep fryer.
